# COASTAL ZONE MANAGEMENT PLAN FOR THE CROOKED RIVER ESTUARY

#### Crooked River Coastal Zone Management Plan

## EXECUTIVE SUMMARY

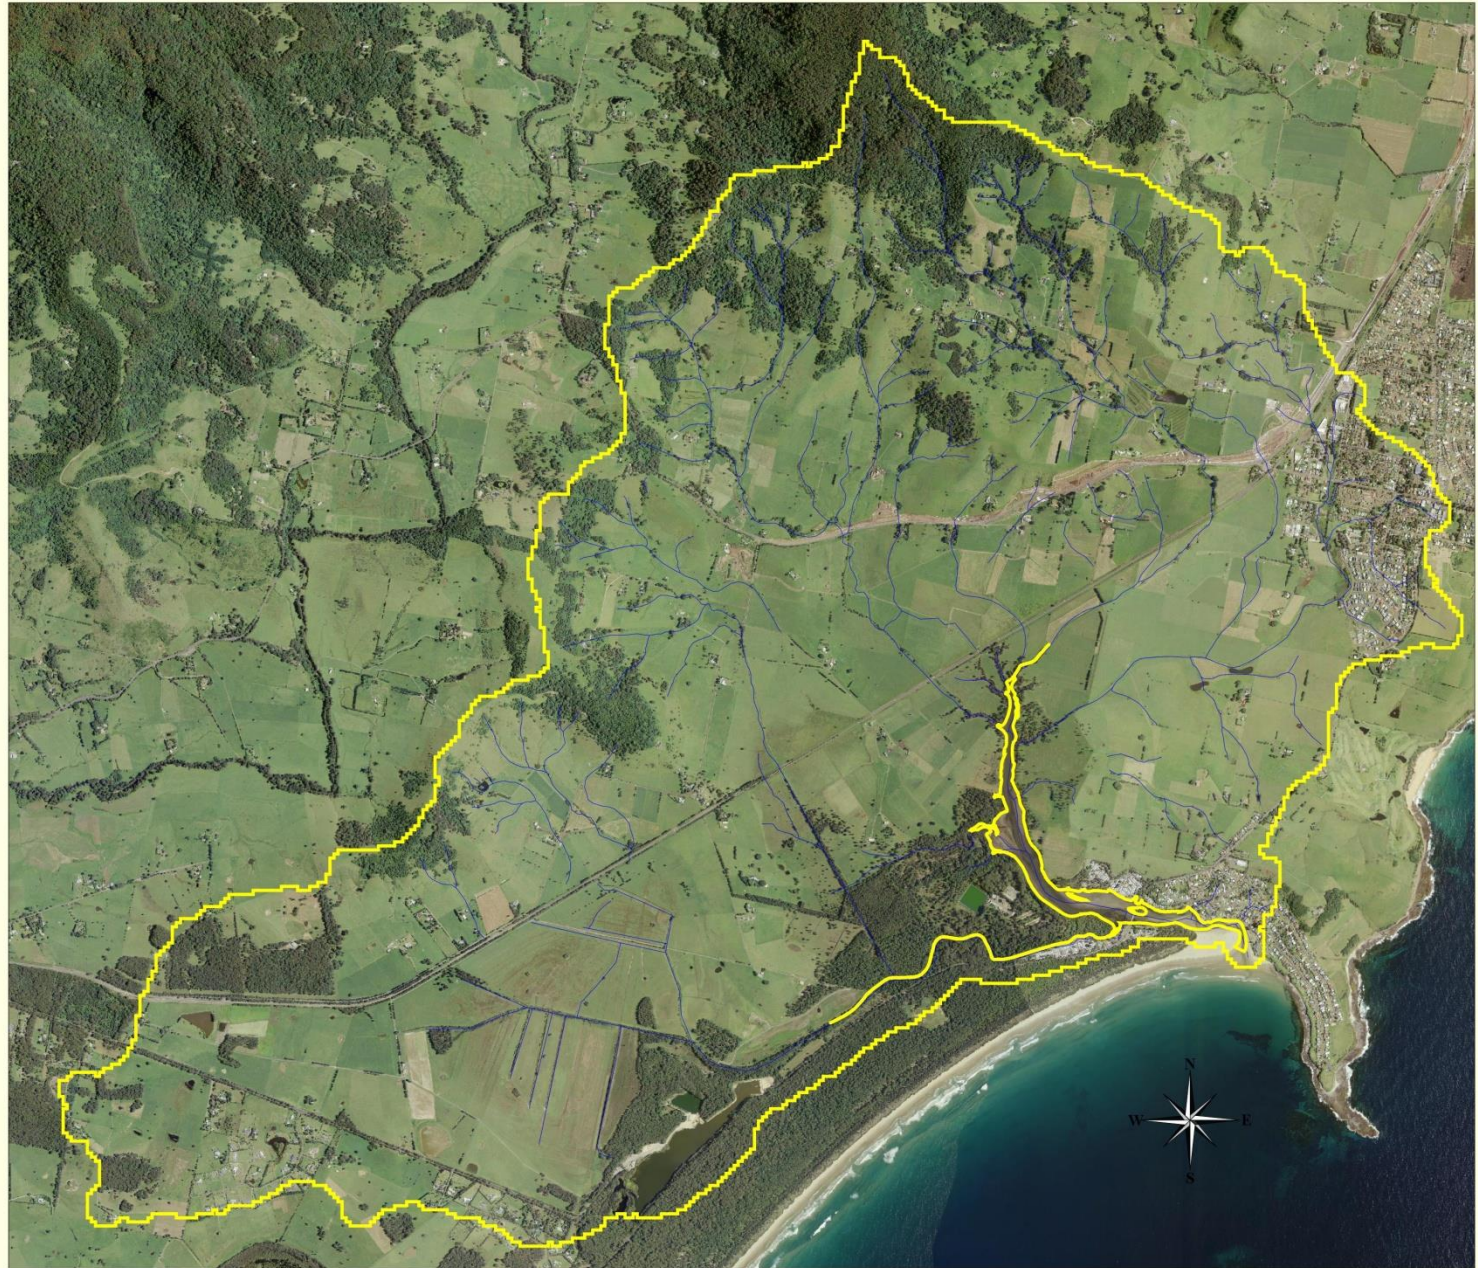
**Figure 1: Crooked River catchment and natural drainage**

Figure 1, depicts the Crooked River catchment area over which this plan applies. The study area comprises the tidal waterways and foreshore adjacent to the Crooked River estuary including the entrance and tributaries. Greater emphasis is placed on the estuarine reach, however consideration is given to other areas of the catchment where issues or processes are potentially affecting estuary health, as the condition of the estuary is heavily influenced by catchment wide factors.

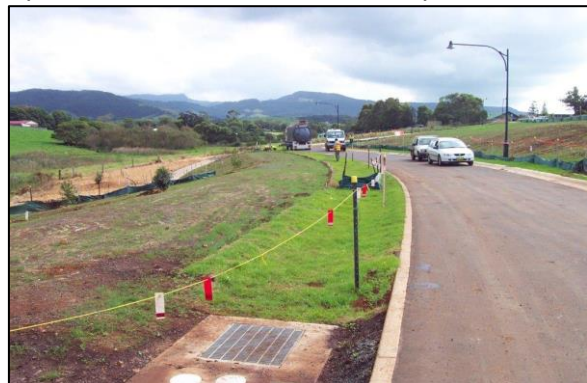
**Union Creek riparian works in Elambra Estate**

- gross pollutant traps (Enviropods) installed in stormwater drains in Burke Parade Gerroa and Elambra Estate Gerringong.
- catchment caretakers program implemented in Gerroa and Gerringong
- wetland / riparian improvements completed as part of the Elambra Estate development
- entrance opening policy position developed by Kiama Council
- townships of Gerringong and Gerroa connected to sewer.

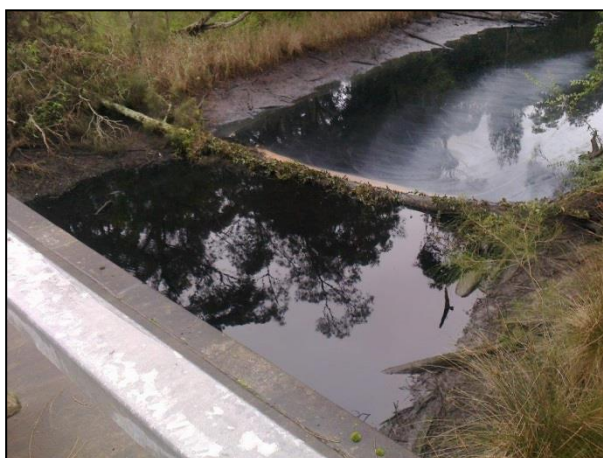
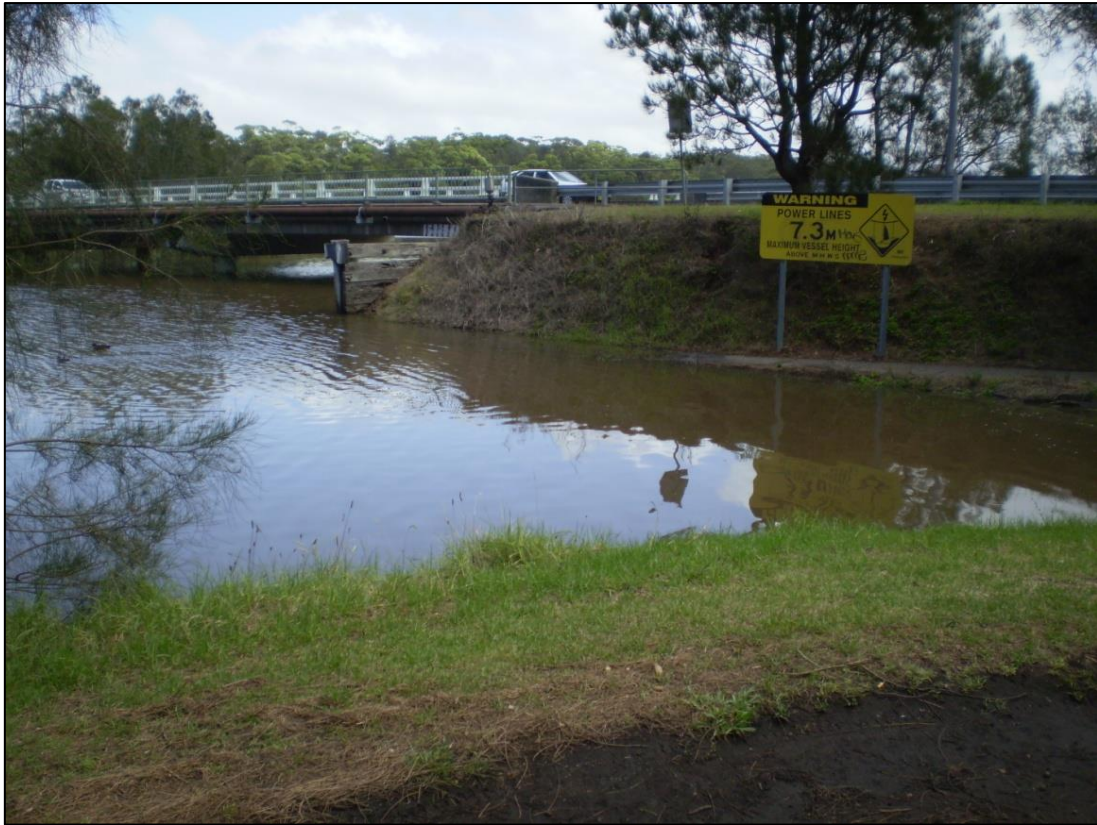
**Figure 4: Flooding of the pedestrian underpass at the Crooked River Road Bridge, Gerroa in January 2012**

Anecdotally, minimal inundation does occur along parts of the foreshore of the Holiday Park fronting the northern bank of the Crooked River and the pedestrian underpass for Crooked River Road is periodically under water (Figure 4). As well as inundation, flood waters have particular impact in the scouring of creek / river banks. A recent incident following a major rain event occurred in the Blue Angle Creek in February 2014 (right), where scouring of the channel exposed the bank sediments to the atmosphere and washed large amounts of organic matter into the creek. Subsequent oxygen demand of the decaying matter and natural sulfate reducing bacteria most likely were responsible for low dissolved oxygen conditions, a sulphurous odour and a small number of fish mortalities.

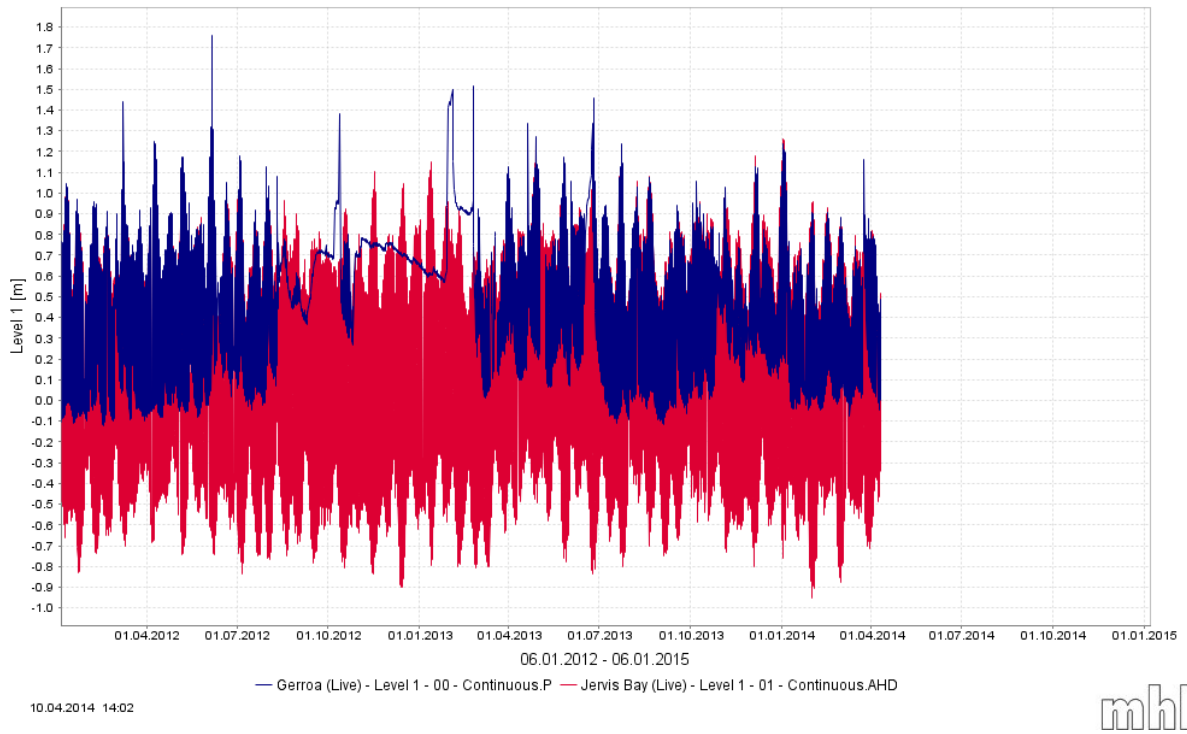
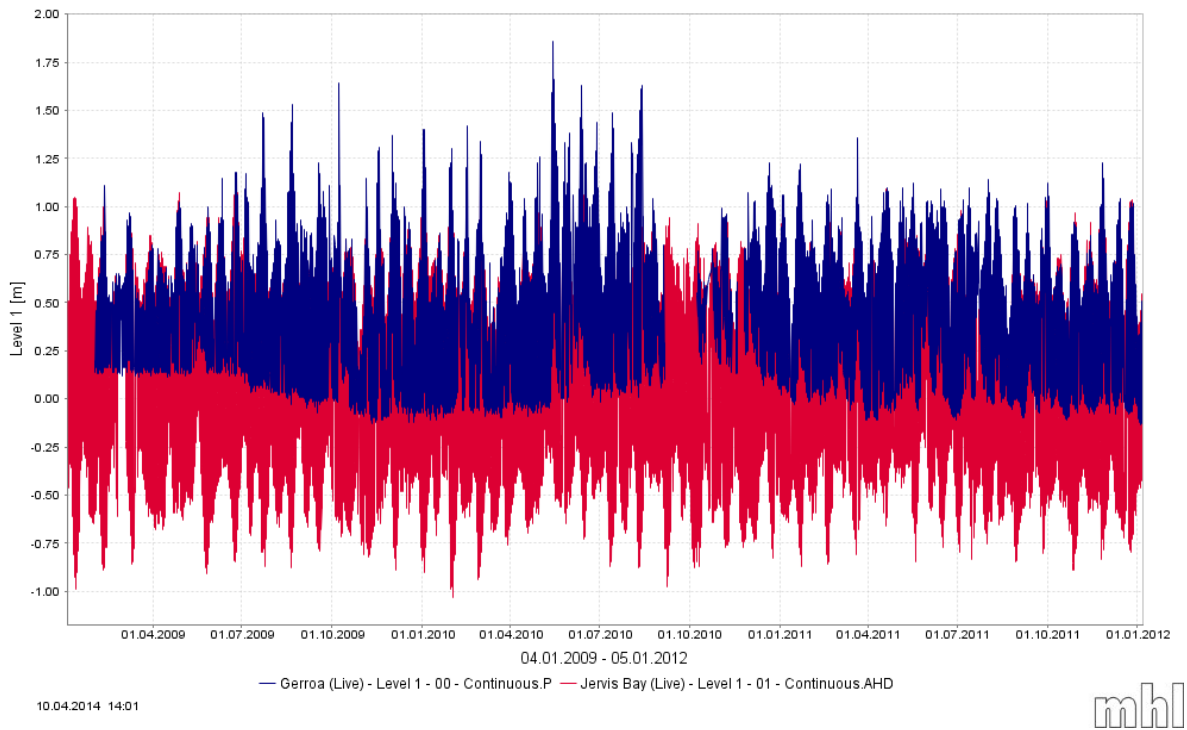
**Figure 5: Crooked River water level gauge data overlaying HMAS Creswell ocean tidal gauge data**

A tidal environment influences the Crooked River estuary when the entrance is open, and due to the river's in-filled nature, tides are enhanced. This facilitates the deposition of marine sediments in the lower reaches of the estuary, leading to sometimes extended periods of closure. Whilst the tidal range of the Crooked River is at times significantly less than the ocean, it appears from the water level gauge data that the high tide propagates into the estuary at near 100% of the ocean tide. This is demonstrated in Figure 5, which is the Crooked River water level gauge data, overlaying the HMAS Creswell (Jervis Bay) ocean tide gauge data. A flushing time of 4.2 days (OEH 2011), means that Crooked River is relatively well flushed when compared with other Intermittently Closed and Open Lakes and Lagoons (ICOLLs).

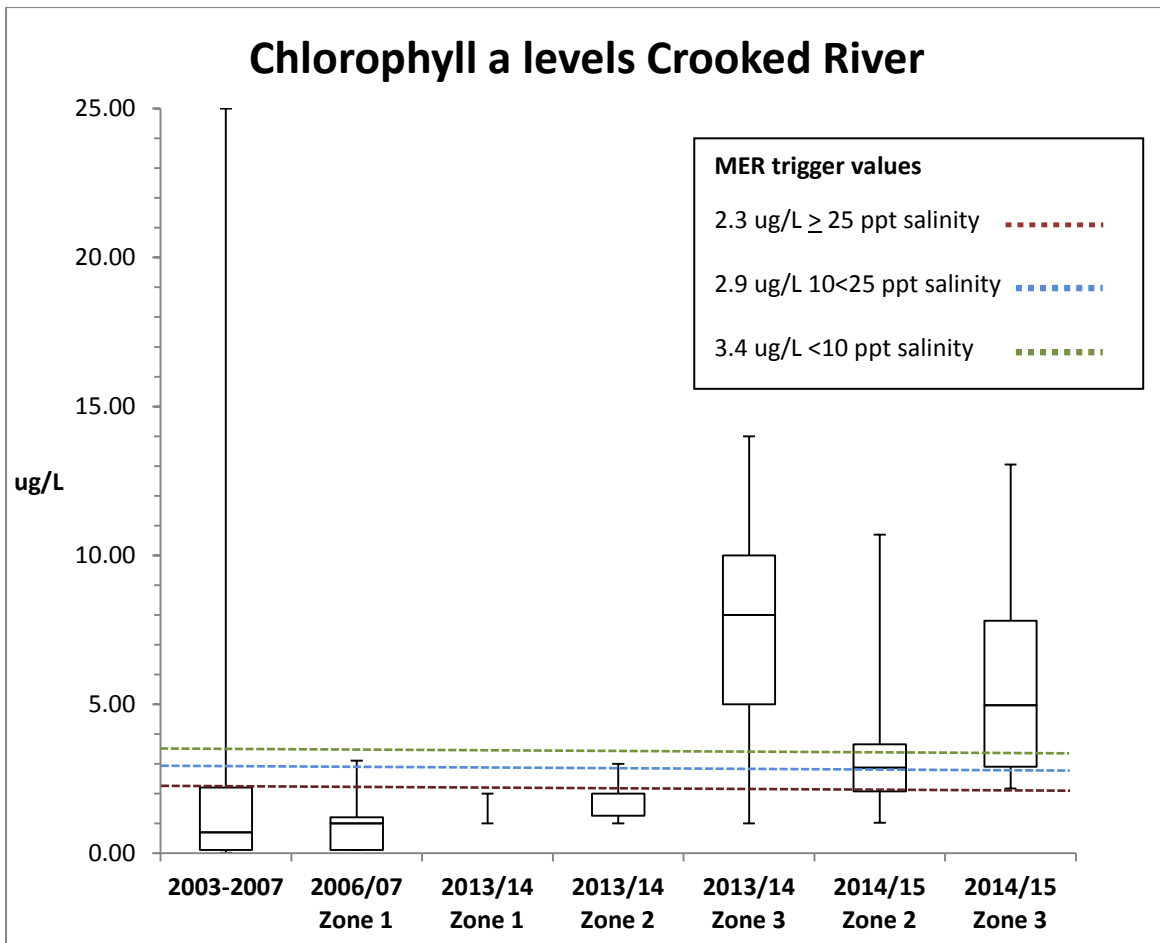
**Figure 8 (a): Chlorophyll a levels Crooked River**

*Chlorophyll a* results showed that of the 12 samples collected and analysed, 4 samples exceed the 2.9 ug/L trigger value identified by the MER program (see Appendix 3). Only 2 zones were sampled as part of this program, which align with the zones 2 and 3 identified in Figure 9. The maximum *chlorophyll a* value recorded was 10.27 ug/L and corresponded with the zone in the upper estuary. The following figures show a comparison of the different Council and MER program sampling data for the Crooked River estuary, the full data set can be found in Appendix 3.

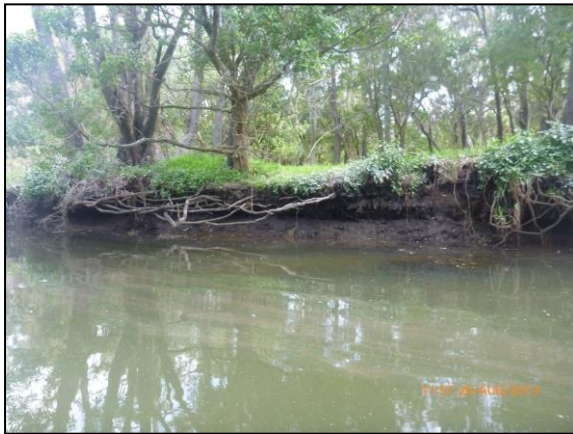
**Figure 11(a) Upper estuary bank erosion**

Formalising access and creating riparian buffer zones may deal with some of the issues. It is expected that a mix of hard (10d) and soft engineering solutions will be required to provide the best outcome for asset protection and ecological and habitat value.

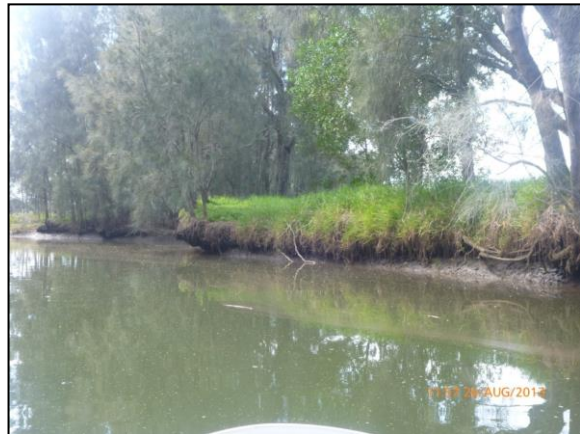
**Figure 11(b) Mid estuary bank erosion**

Many of the estuary foreshores are exhibiting signs of erosion, some areas showing slow progressive recession of the shoreline and/or undermining of existing riparian vegetation (Figures 11a and 11b). Whilst in many areas this is a natural part of river bank behavior and there is a vegetated riparian zone which helps to mitigate the erosion, there are areas where little or no riparian vegetation is present. This leaves these areas more vulnerable to the effects of wind, wave and tidal/flood current erosion, and damage by livestock. There are also areas within the estuary such as stretches of Blue Angle Creek where heavy rains have caused channel erosion and exposure of anoxic sediments leading to low dissolved oxygen issues in the water column. A recent event occurring in February 2014 introduced organic matter and exposed anoxic sediment in the main creek channel below the tidal flood gate, leading to a rapid decrease in dissolved oxygen concentrations and subsequent impacts on fish, invertebrates and amenity of the creek.

Options	Description	Figure	Pros	Cons
Manage erosion occurring on Council controlled and community land	Engage engineering expertise to assess and propose design plans for bank erosion occurring in Blue Angle Creek and Crooked River	Figure 11,12 Action 2.1	Reduces sedimentation of the Crooked River estuary  Benefits assets which are at risk from erosion  Can be used to formalize access to riparian area	High cost of rock wall stabilization and other engineering solutions  A substantial flooding event may still result in erosion of the bank  Maintenance of rock walls

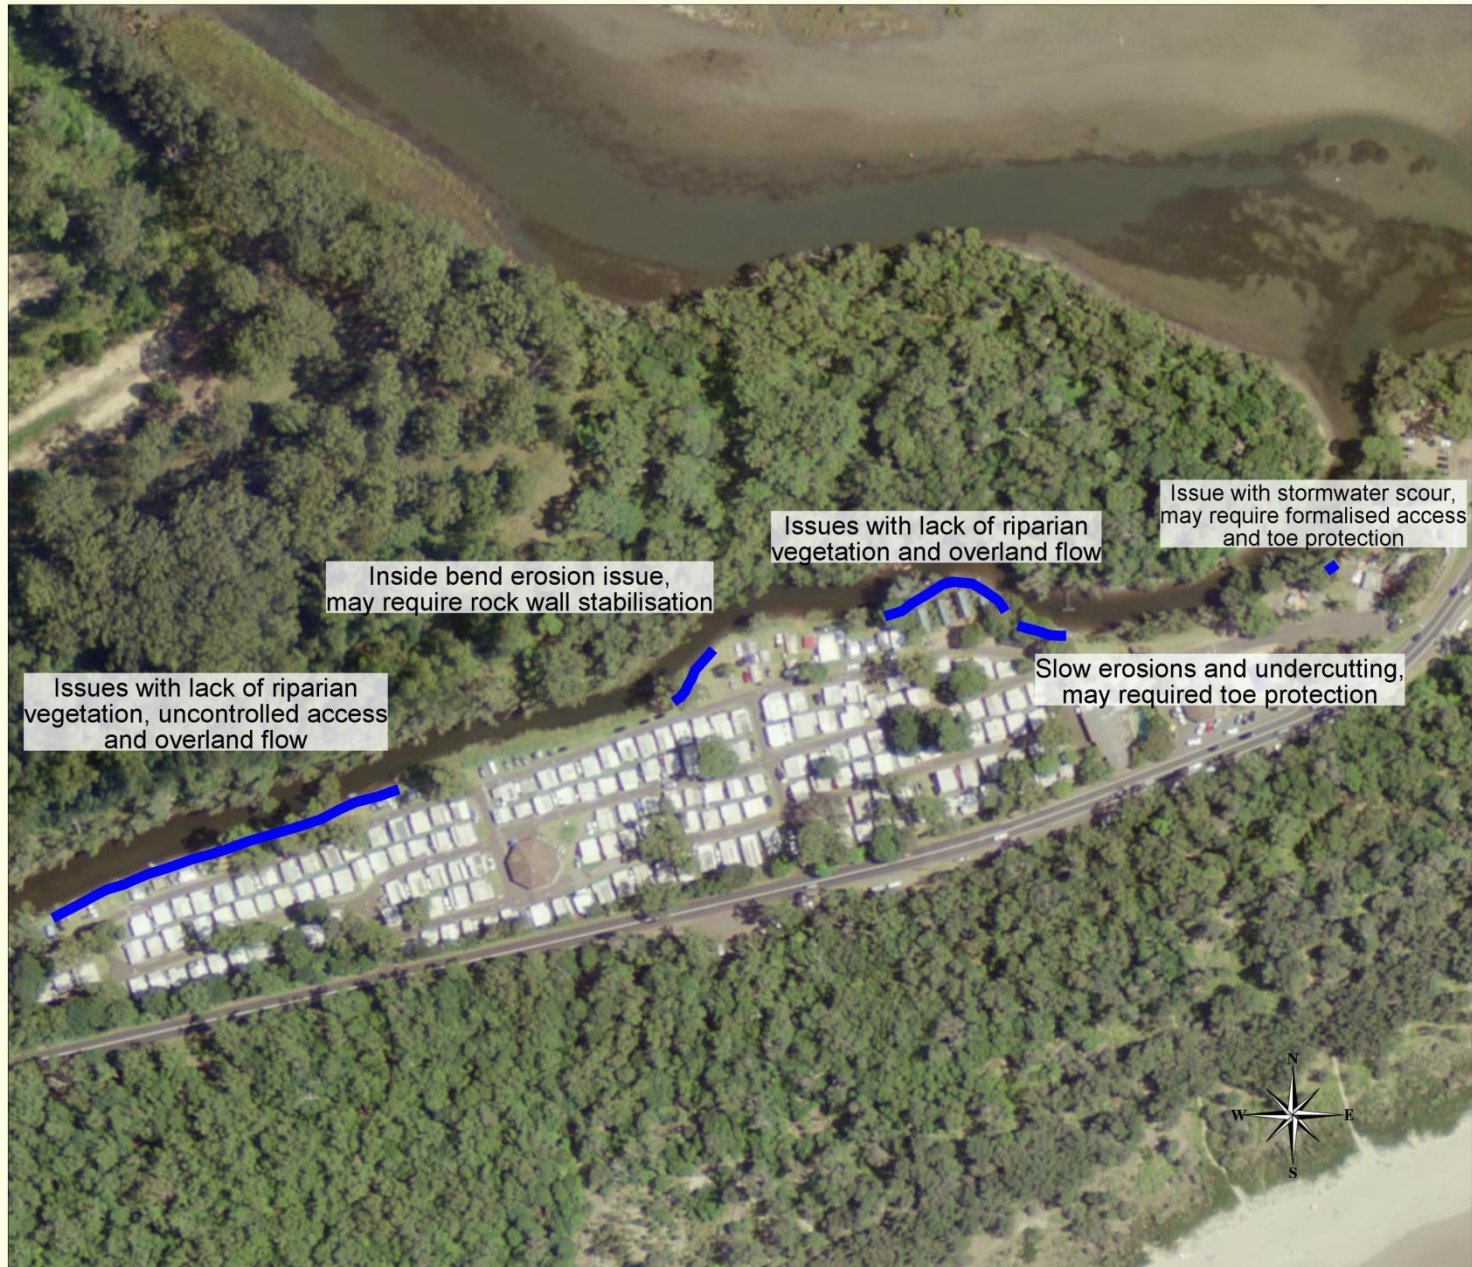
## Blue Angle Creek bank erosion

of the Seven Mile Beach Holiday Park operations and should be a targeted priority for future action (Figures 11c, 11d and 11e). The areas of concern are identified in the Figure 12 map, which is a high use and high profile areas. Some of the causes could be related to the removal of emergent macrophytes and riparian vegetation to access areas of the creek for recreational purposes.

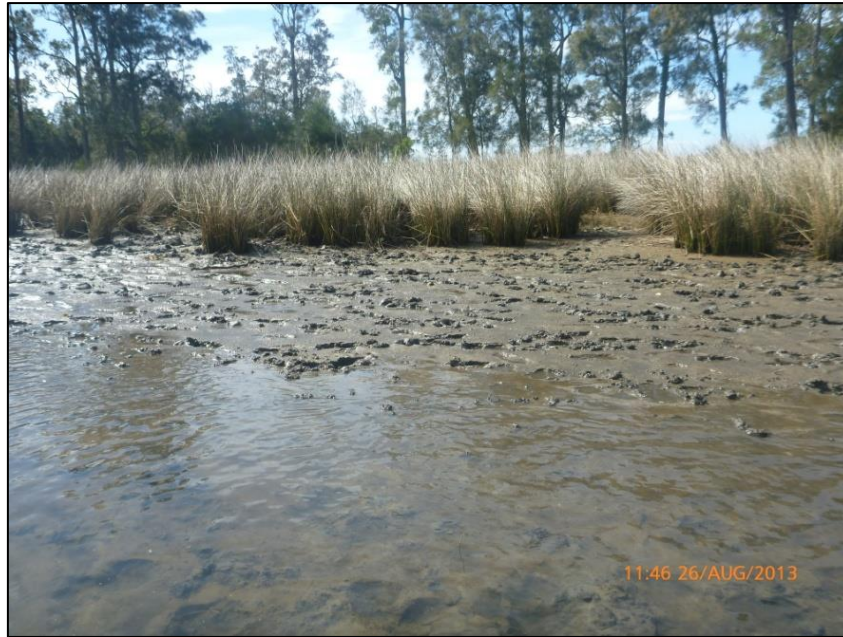
**Figure 15: Evidence of stock access to the main Crooked River channel**

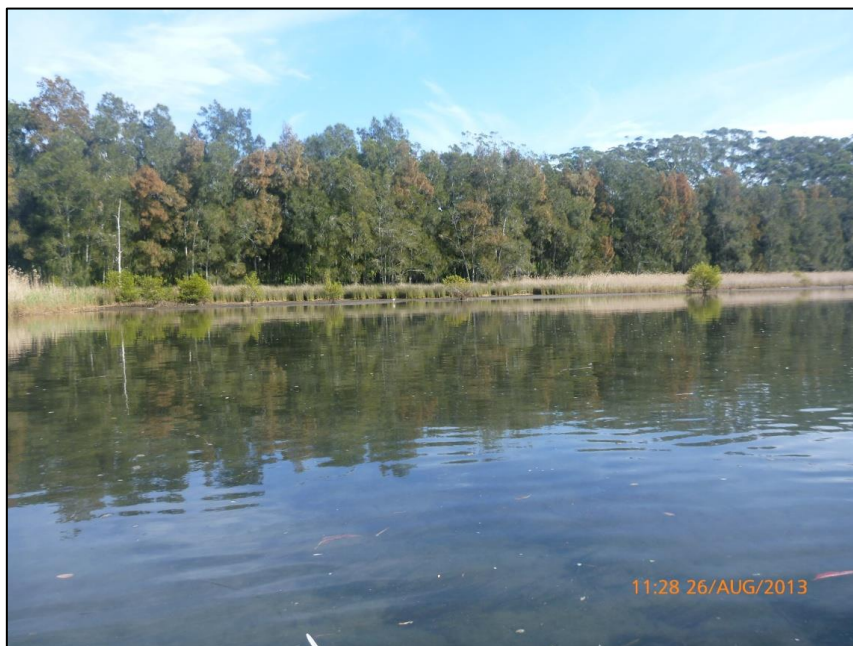
**Figure 16: Sporadic mangroves in the mid estuary of the Crooked River**

Figure 14 identifies the location of mangroves located in the Crooked River system as mapped by West (2005). During the 2013-14 ecosystem health monitoring undertaken by Kiama Council, mangroves within the Crooked River estuary were observed to be in various states of health (Figure 16). There were many small mangroves observed, with some looking in a dead or dying state, more than likely due to extended periods of inundation when the Crooked River has been closed to the sea. It was also noted in field observations by Council and OEH officers in July 2015 that whilst there are a number of dead mangroves present throughout the system, there are also many semi mature mangroves which appear to have been established for a number of years throughout the system which are not captured in the estuarine habitat mapping.

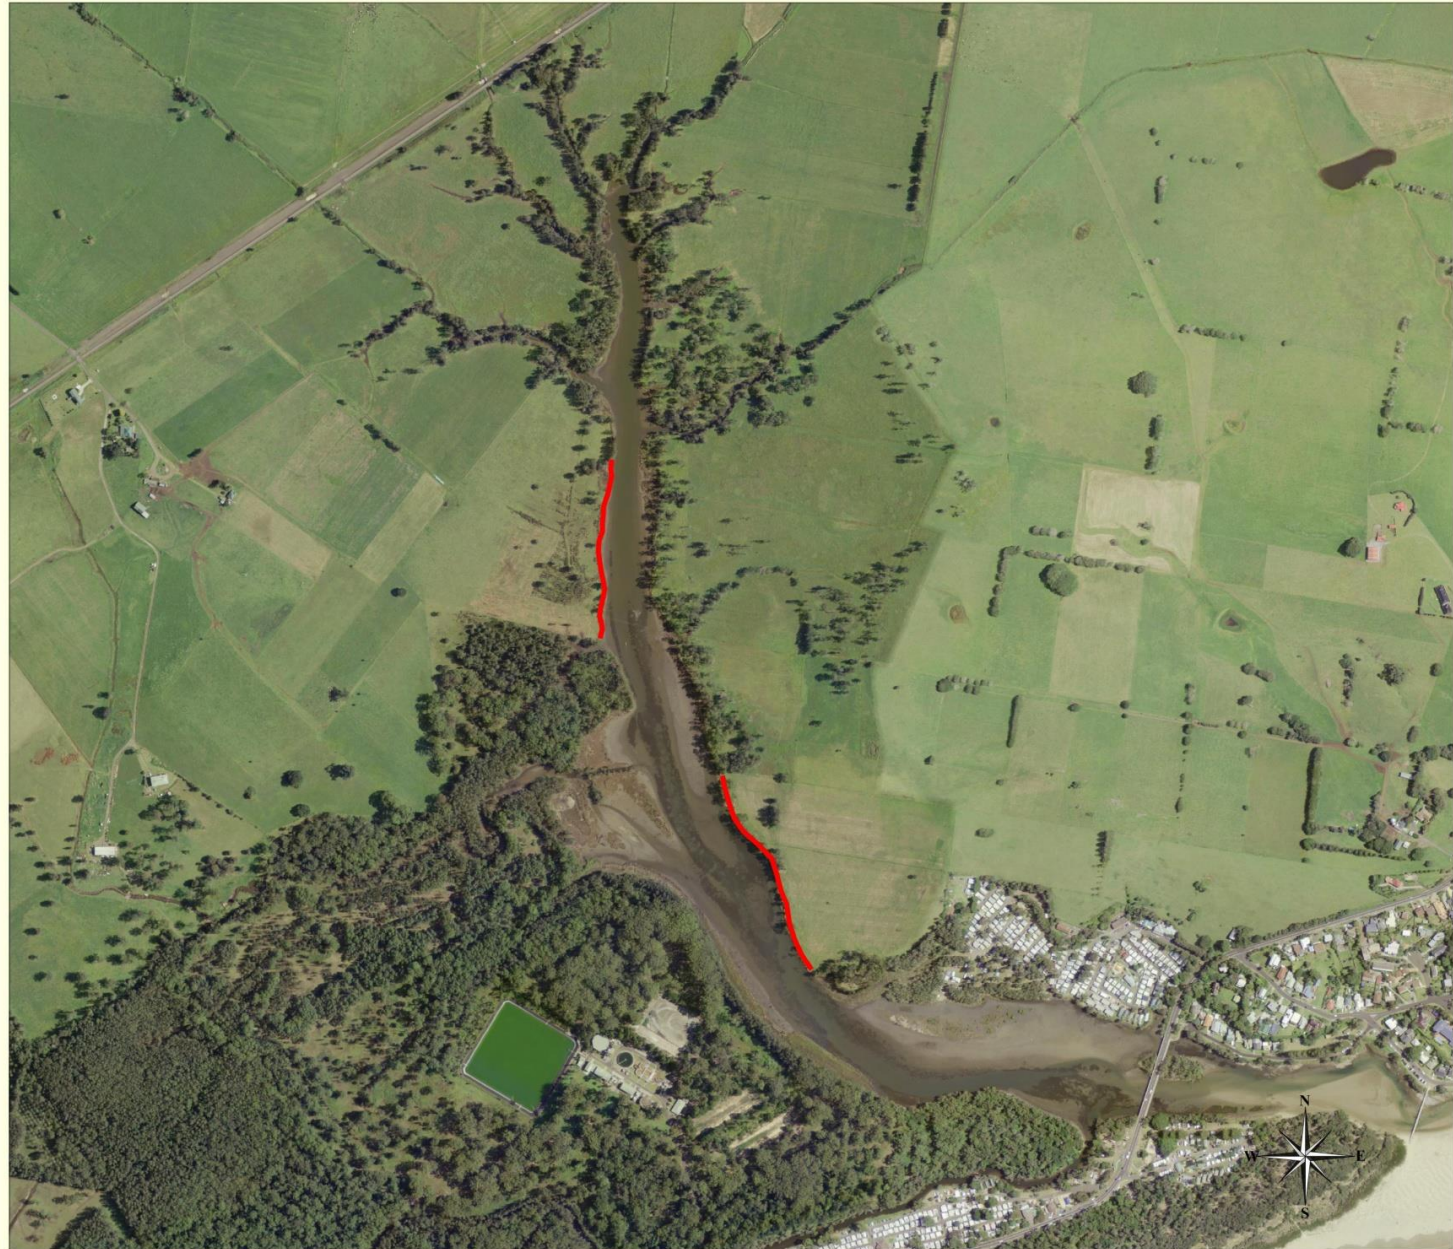
Figure 17: Crooked River main channel riparian revegetation opportunities

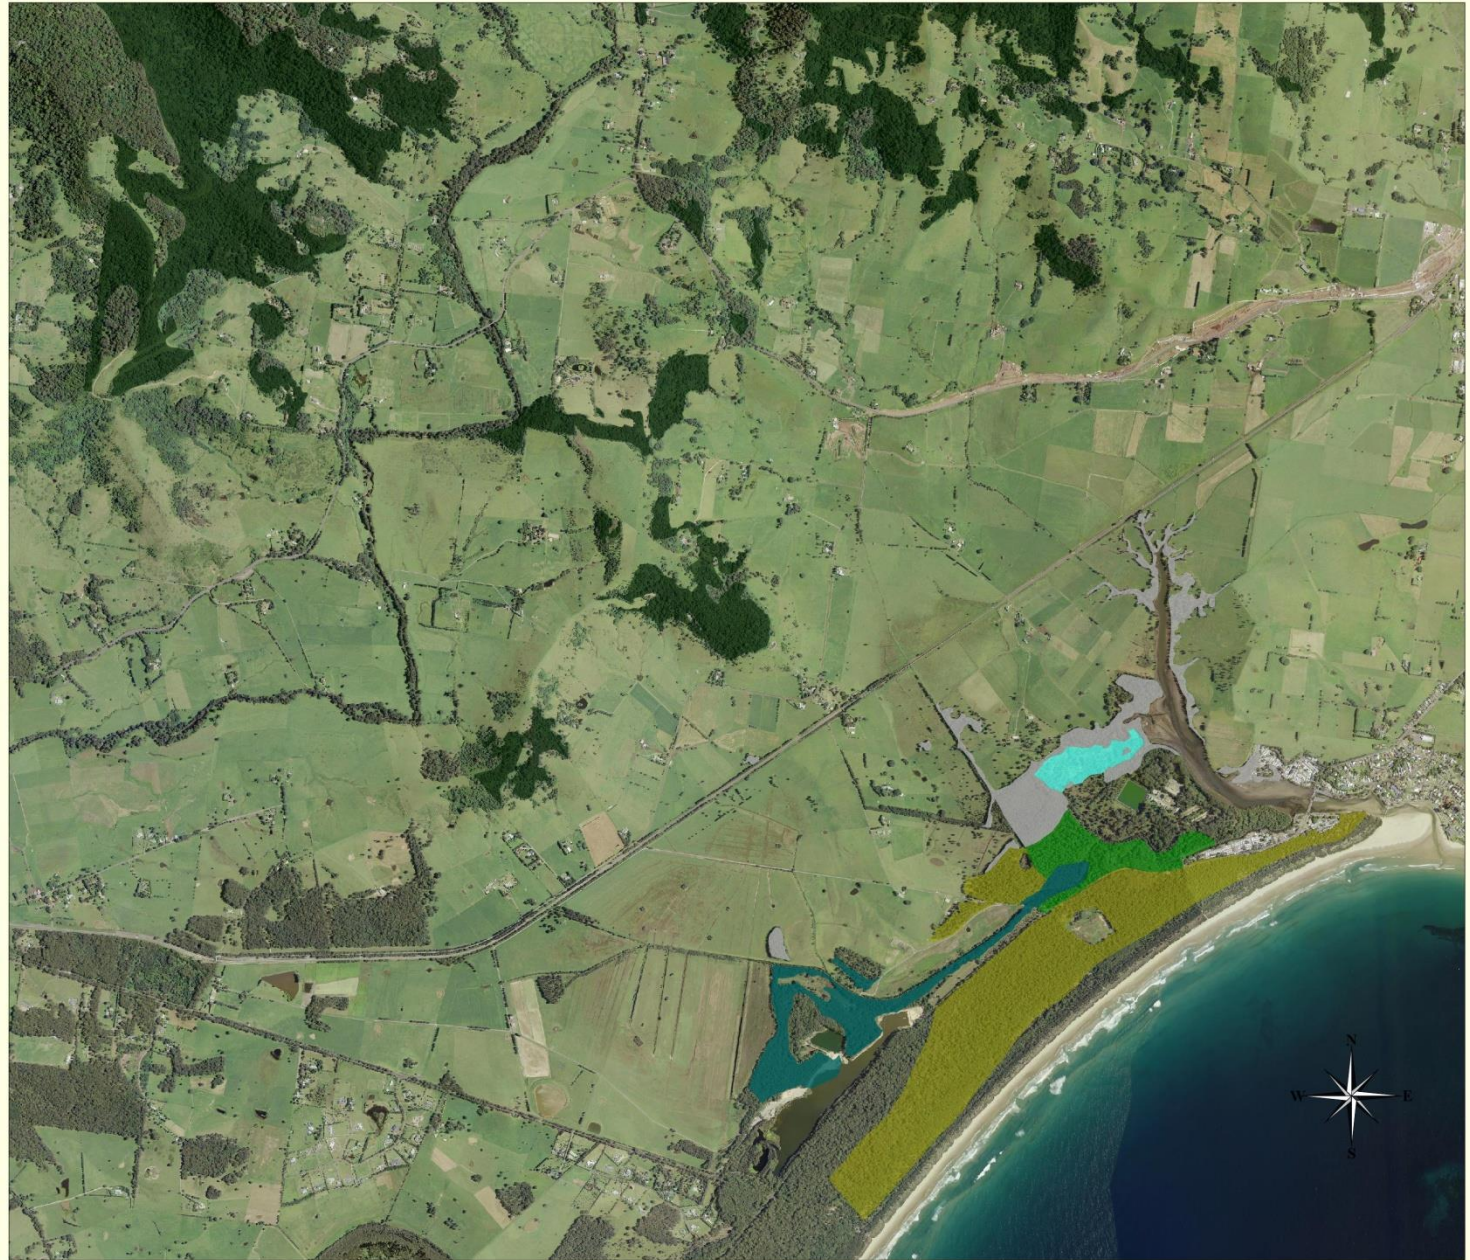
**Figure 18: Endangered Ecological Communities of Crooked River catchment**

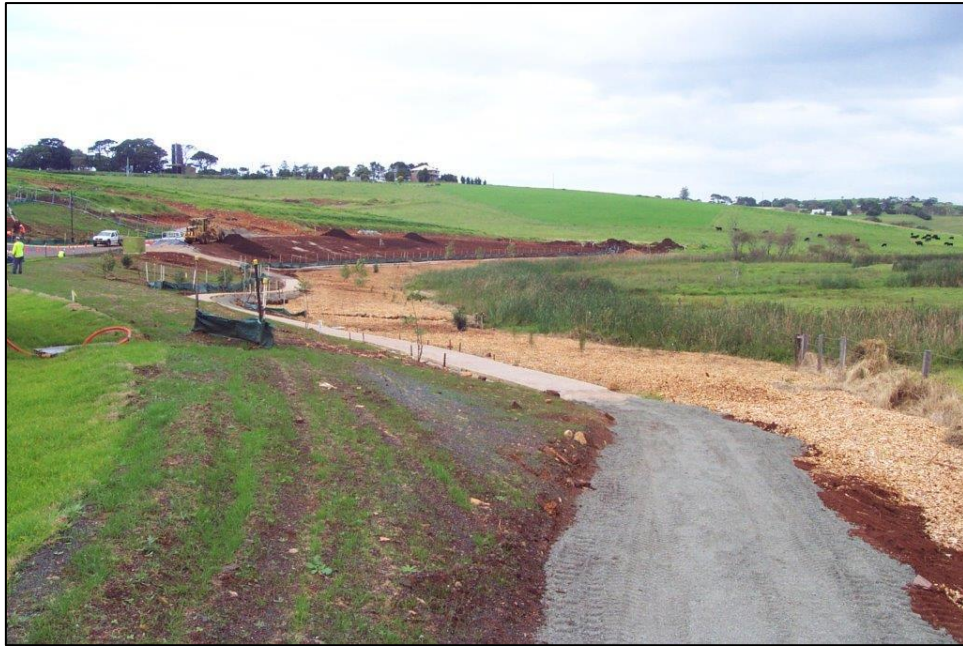
**Figure 21: Riparian rehabilitation Elambra Estate**

To deal with the change of land use and potential for environmental impacts associated with residential development of Elambra Estate, Kiama Council created Chapter 22 of Council's Development Control Plan 2012 dedicated to Elambra Estate – 'Chapter 22 – Site Specific Controls Elambra Estate'. Development controls include the requirement for onsite stormwater retention and re-use, all lots to be connected to sewer and dedication of riparian land abutting Union Creek is to be rehabilitated and dedicated to Council as public reserve. A Union Creek Plan of Management was also prepared, which detailed the requirements for the management of the riparian lands included in the Elambra Estate development including riparian plantings (Figure 21). The Union Creek Plan of Management can be viewed at Kiama Council's website [www.kiama.nsw.gov.au](http://www.kiama.nsw.gov.au), under the plans and policies section.

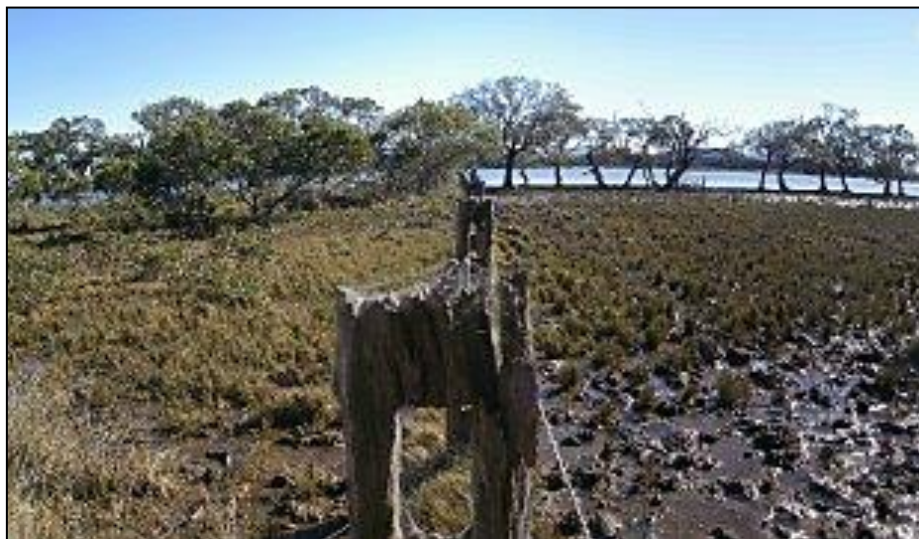
**Photograph sourced from NSW DPI website showing the impact of stock exclusion fencing on riparian zones (Photo L.Bogie)**

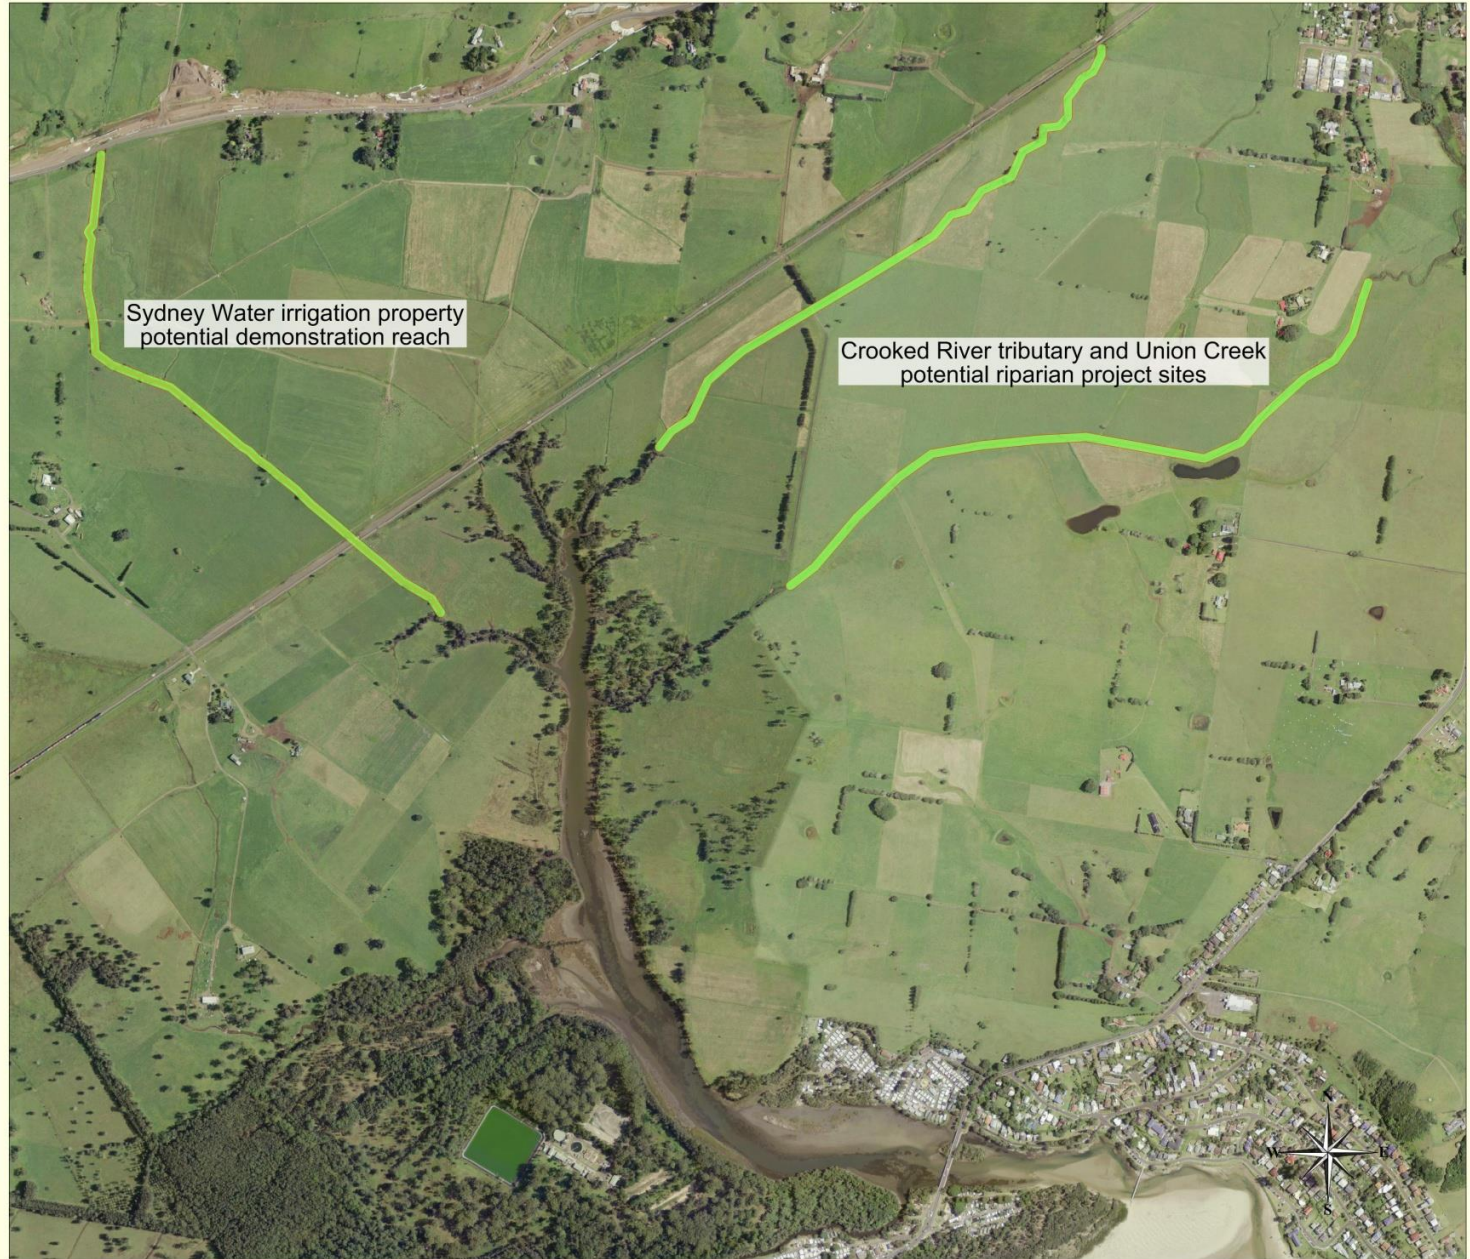
Sydney Water irrigation property potential demonstration reach

Crooked River tributary and Union Creek potential riparian project sites

The demonstration reach concept would undertake projects to improve estuary health outcomes such as stock exclusion, off stream watering and riparian revegetation project which would be utilized to promote these activities within the catchment. A potential site has been suggested in Figure 23, as well as identifying other tributaries which could be considered for demonstration reach projects. The demonstration reach concept provides an opportunity to kick start or build momentum for investment in natural resource management strategies within a catchment, through completion of small scale projects which can be utilized in field days and build community connection through communication of ideas and methodologies. These projects are generally funded through grant funding opportunities and supported through state government agencies such as South East Local Land Services and the Department of Primary Industry.

<b>Options</b>	<b>Description</b>	<b>Figure</b>	<b>Pros</b>	<b>Cons</b>
Develop best practice demonstration sites for riparian land management within the Crooked River catchment	Riparian revegetation, stock exclusion and off stream watering projects	Figure 23 Action 1.1, 1.7, 3.3	Creates buffer between stock and direct water access  Potential to attract interest from other landholders in the catchment  Provides filtration for runoff  Relatively low cost for implementation	Requires buffer area on productive land  Funding support required  Landholder acceptance required  Ongoing maintenance requirements
Publishing estuary health data	Create and publish estuary health report cards to communicate with the community	Action 1.3	Easy to understand communication tool  Provides broad trend analysis on water quality in the estuary	Annual water sampling required to complete the report cards  Costs to sample on annual basis  Not targeted to identify sources of nutrients and turbidity

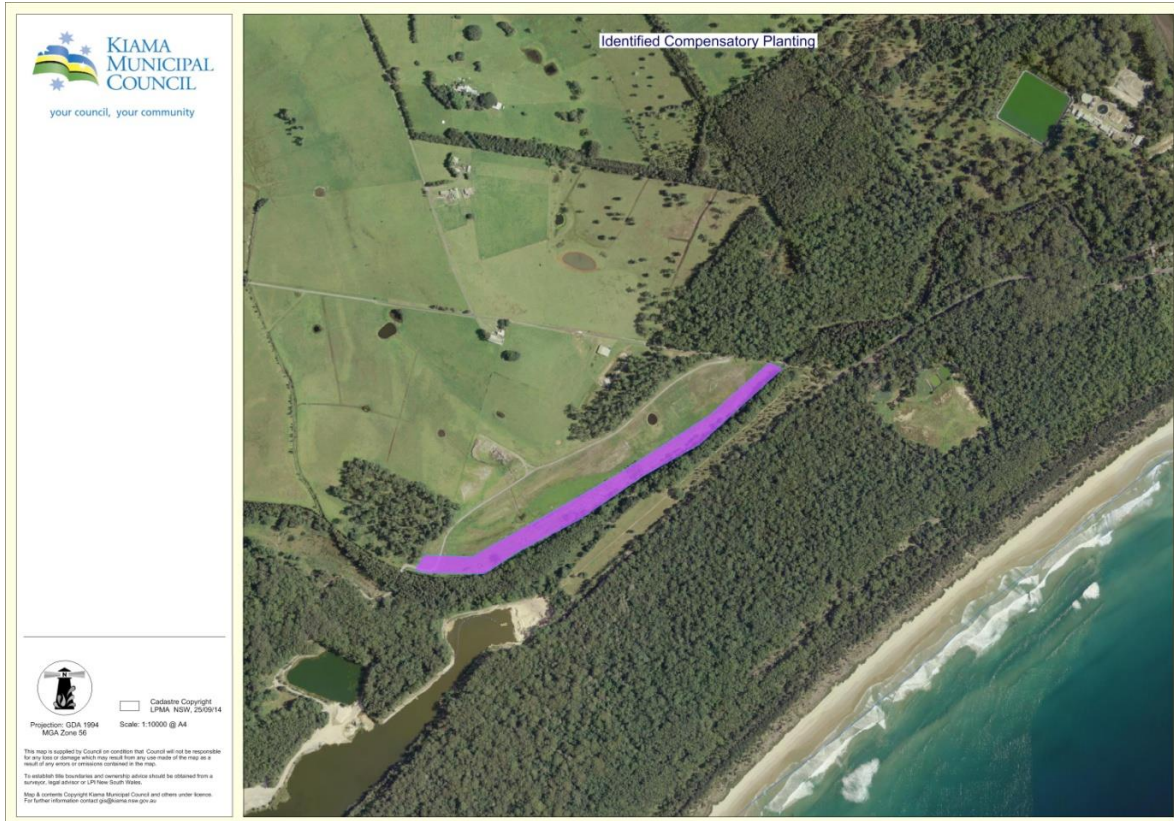
**Figure 24: Future compensatory planting for Blue Angle Creek which will reduce the potential for flood scour**

In February 2014 a flood scour event in the Blue Angle Creek catchment led to oxygen depleted conditions and a small fish kill in the Blue Angle Creek below the flood gate. A field assessment by Council staff, Cleary Brothers representatives and Office of Environment and Heritage officers found the event to be naturally occurring, but exacerbated by the enhanced draining capacity of the cleared land above the floodgate. It was identified that the planting out of the compensatory corridor along Blue Angle Creek may assist to reduce the impact of flood scour in future. This planting is identified in Figure 24, and is identified to be completed as part of the consent conditions for the extension of the Gerroa sand mining operation. The compensatory plantings already underway on the Cleary Brothers site as part of the development consent conditions detailed in the Gerroa Sand Resource Quarry Environmental Management Plan (2009), can be seen outlined in Figure 25. This revegetation demonstrates how projects can be implemented to provide connection of fragmented vegetation patches across a landscape. These figures identify approximate locations of the revegetation activities and should not be used to determine if compensatory plantings have been carried out in compliance with the QEMP 2009 and consent conditions.

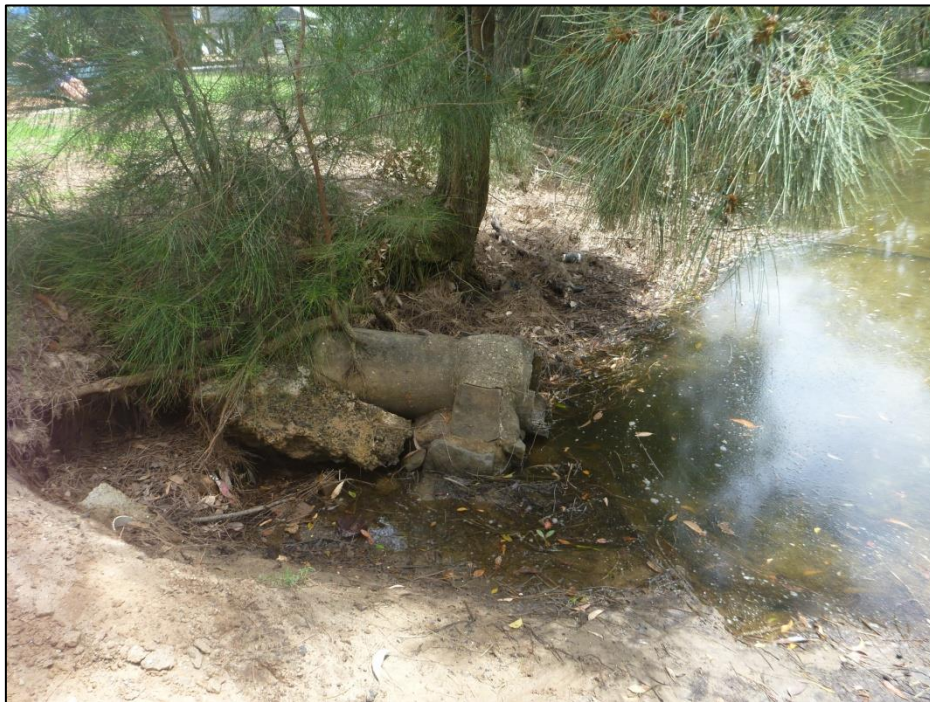
**Figure 26: Seven Mile Beach Holiday Park kayak launch site, stormwater outlet**

There is the opportunity to develop more formalized kayak / canoe launching facilities to assist in protecting bank areas and provide ease of access to the public. One proposed site is the current canoe / kayak access in the Seven Mile Beach Holiday Park. Currently an informal 'sand' beach area is utilized and is seasonally washed away by floods and tide. A properly designed formalized access would help protect the bank from erosional forces related to pedestrian access, flood and stormwater scour (Figure 26). Another potential location is at the end of Park Road Gerroa, near to the path under the road bridge.

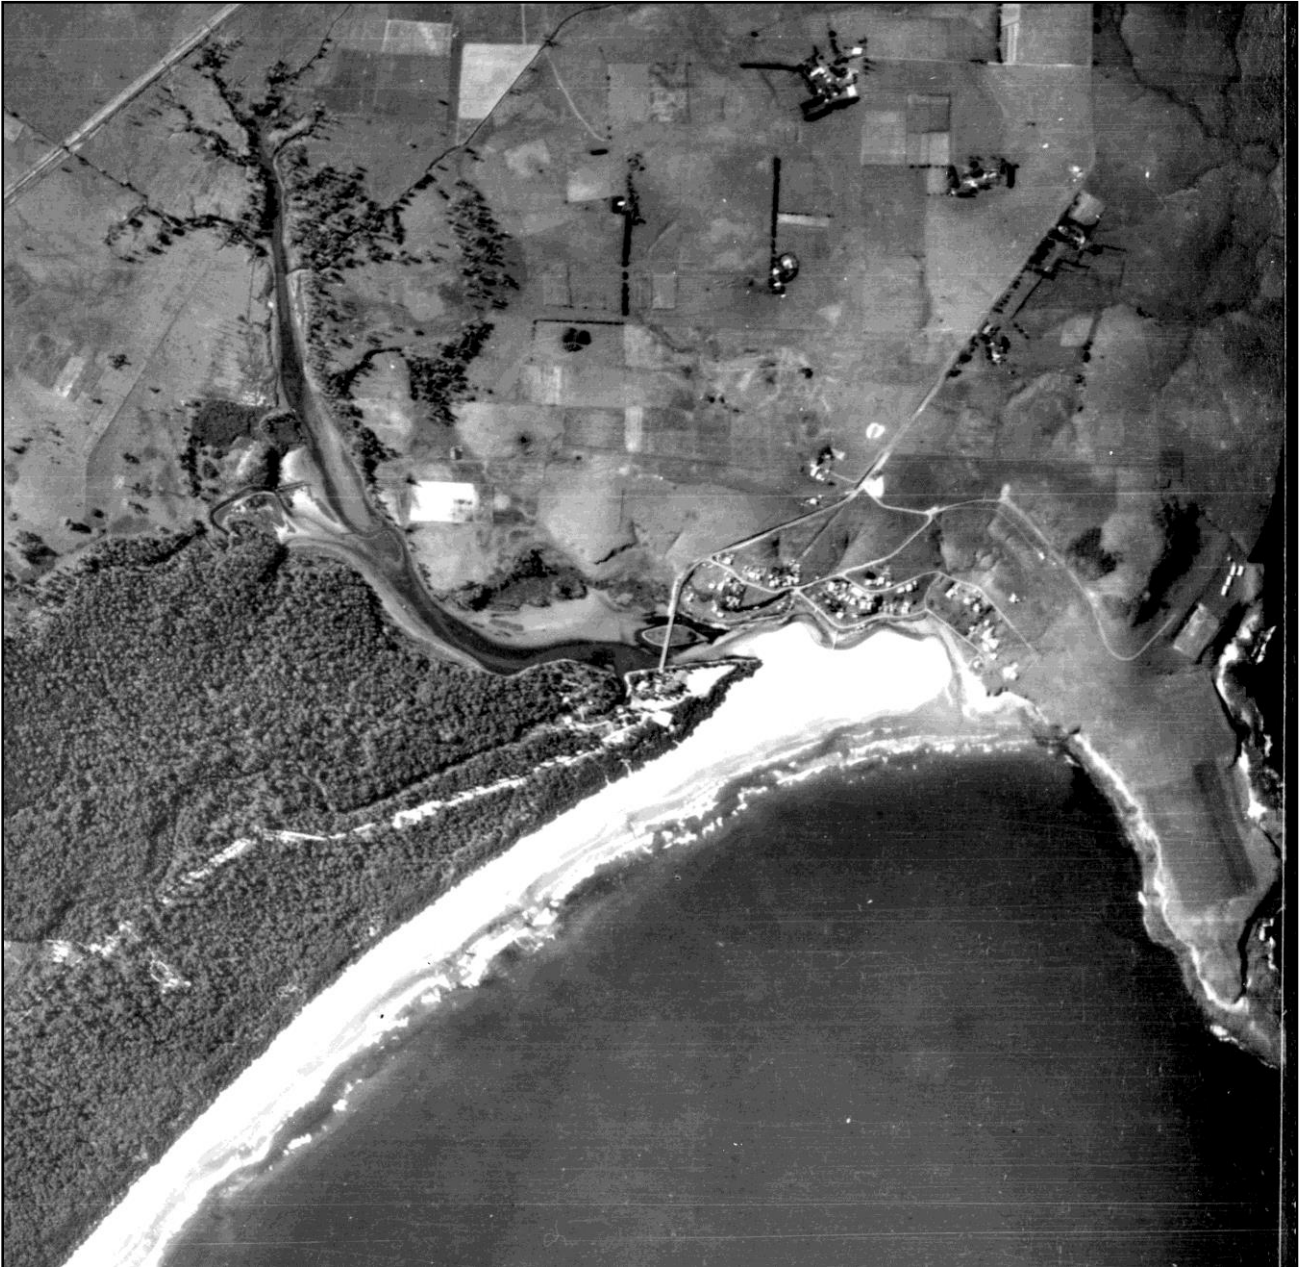
### **Crooked River Estuary 1949**

Estuary open to the ocean

Large sections of the upper estuary foreshore and catchment cleared, as pre present day

Entrance channel alignment along the northern foreshore
