# COASTAL ZONE MANAGEMENT PLAN FOR THE CROOKED RIVER ESTUARY

#### Crooked River Coastal Zone Management Plan

## EXECUTIVE SUMMARY

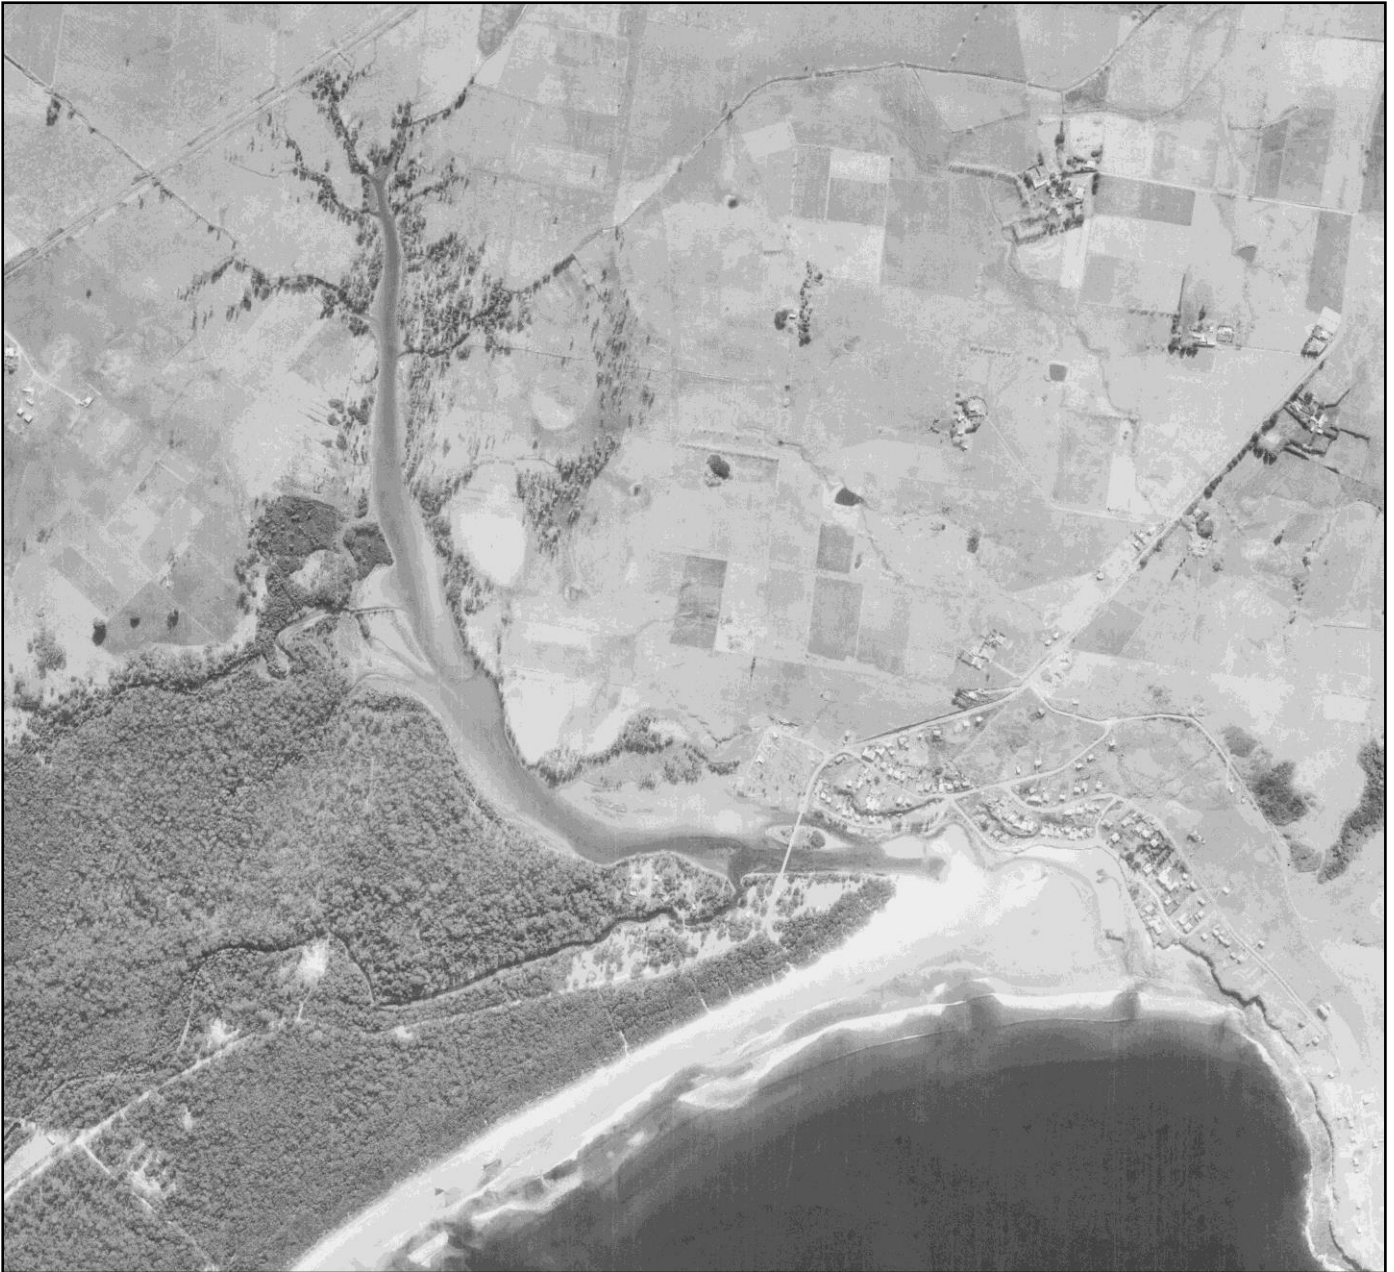
**Crooked River Estuary 1963**

Estuary barely open to the ocean

Seagrass appears to be present in the lower estuary around Blue Angel Creek, reduction in extent of seagrass in the mid to upper estuary

Development of southern and northern caravan park sites apparent

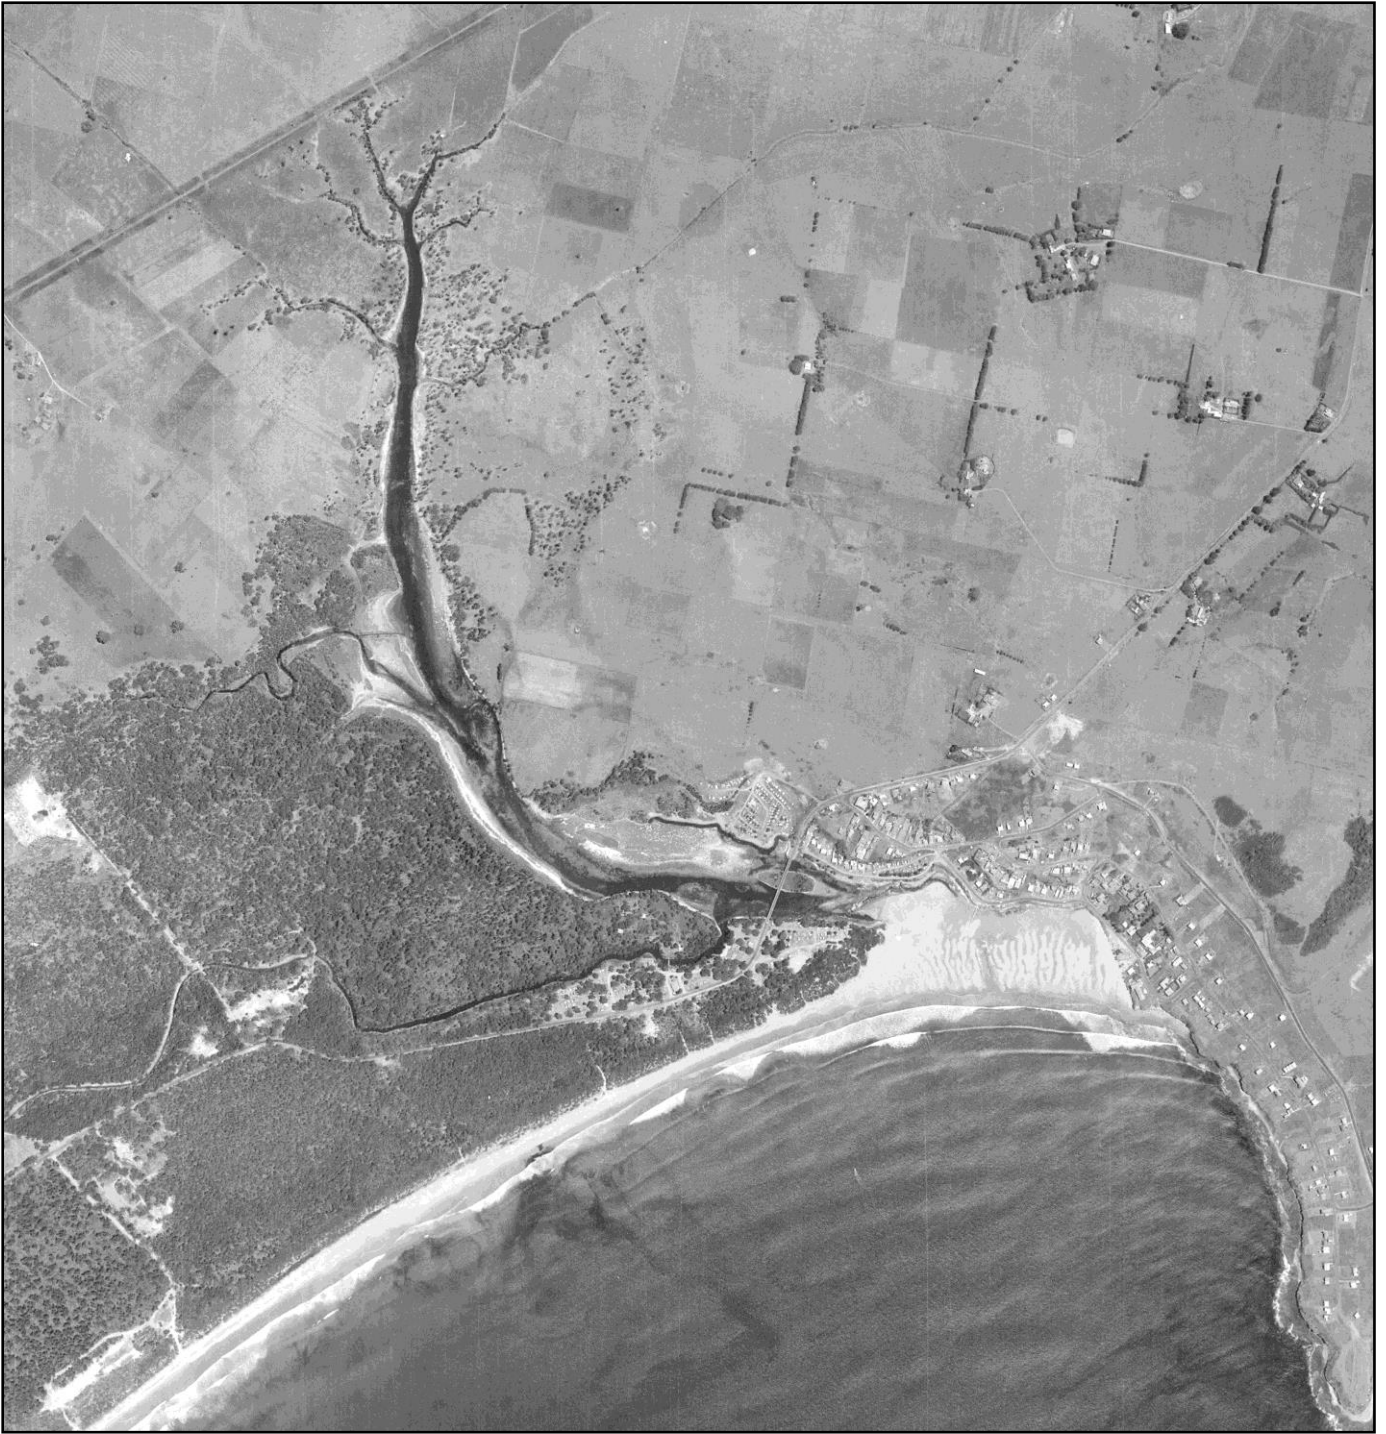
**Crooked River Estuary 1969**

Seagrass appears to be present through much of the estuary

Estuary closed to the ocean by wide sand berm

Development of both southern and northern caravan parks clearly visible

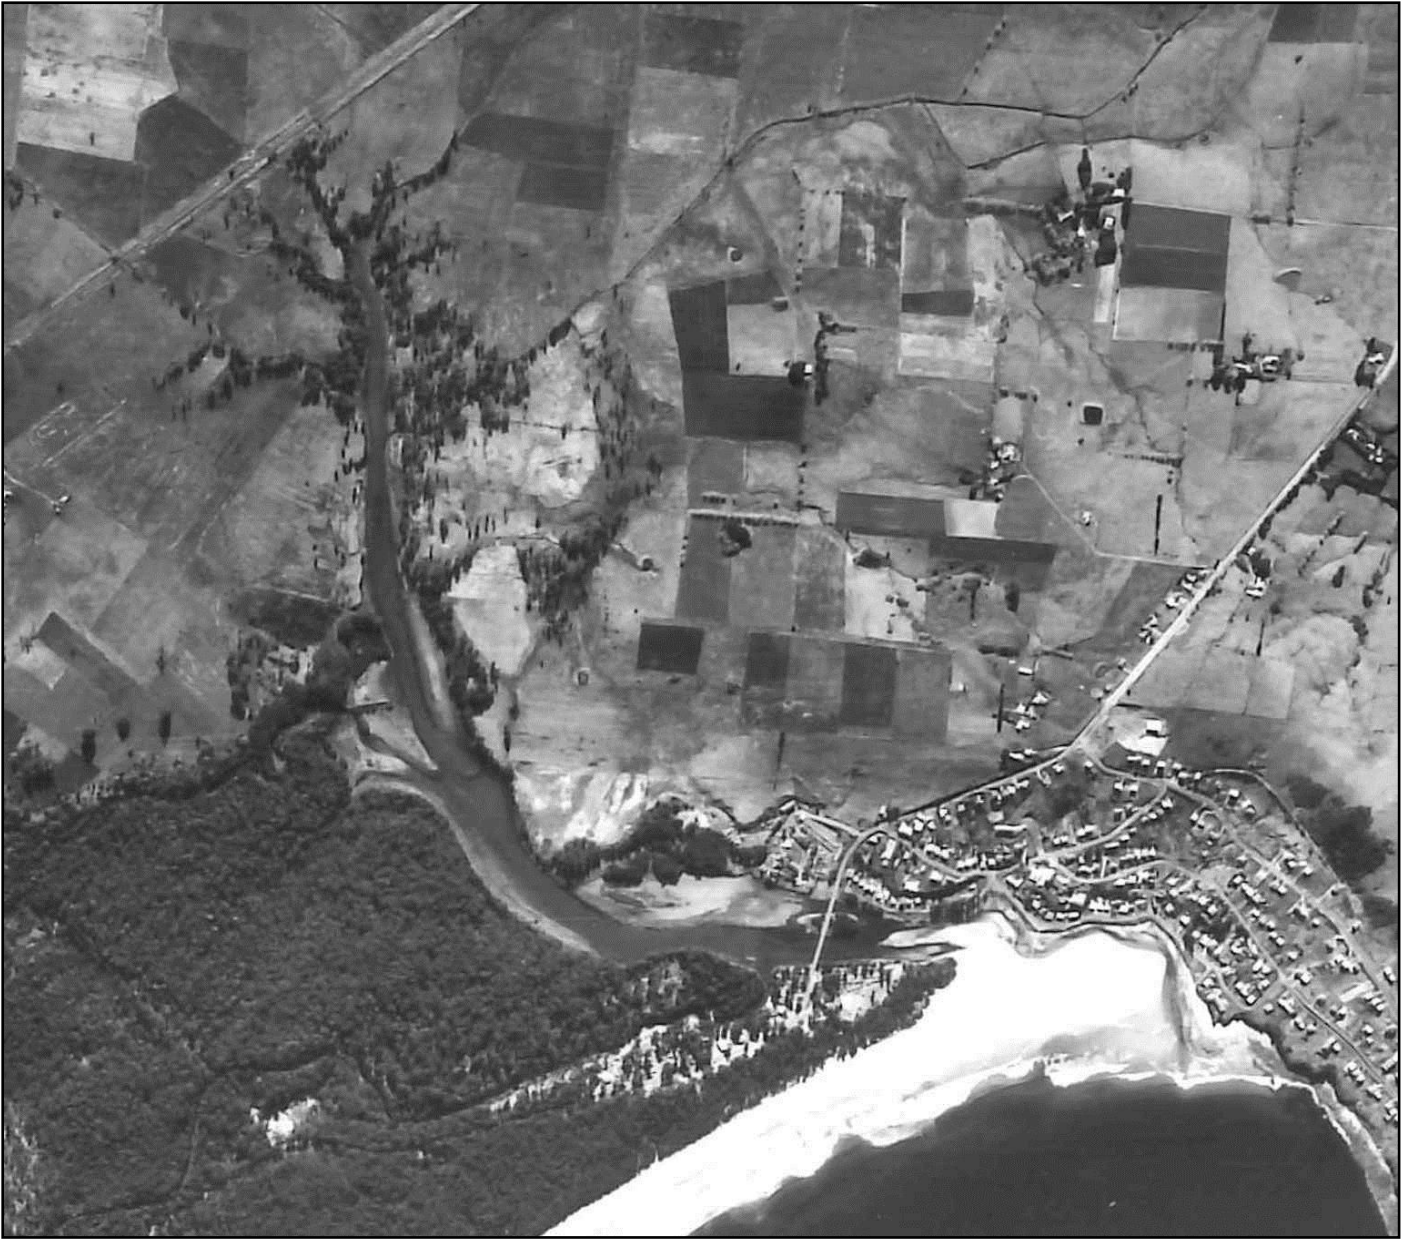
**Crooked River Estuary 1979**

Estuary open to the ocean

Seagrass appears to be sparse throughout the system, most noticeably around mid to lower estuary

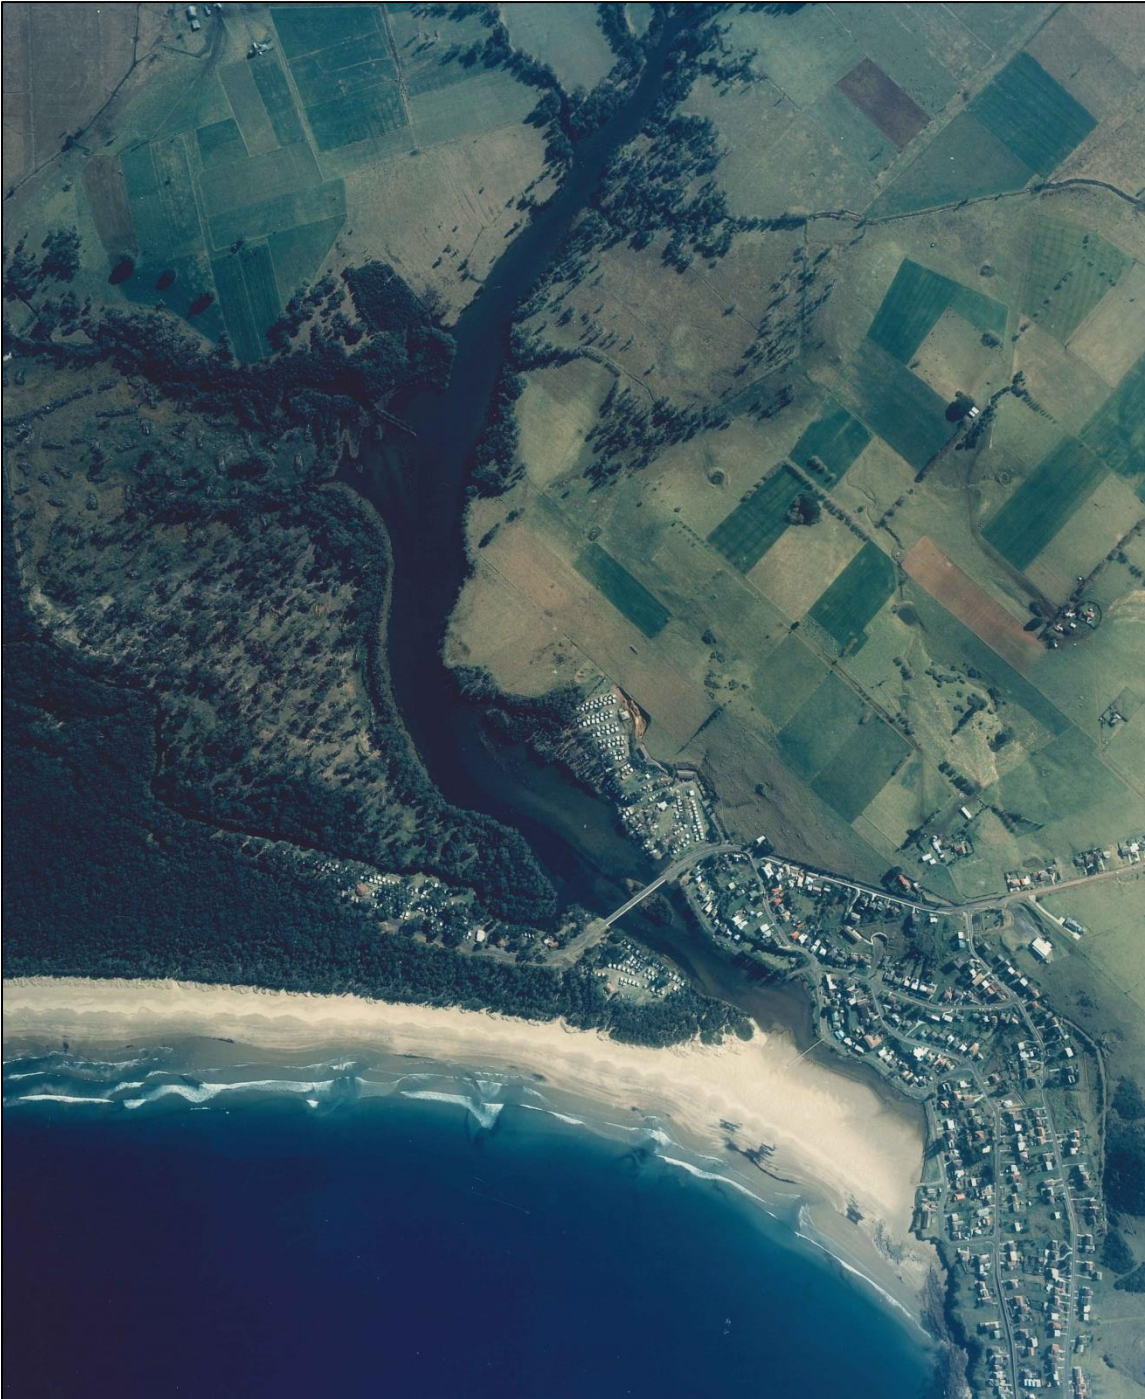
**Crooked River Estuary 1987**

Entrance closed to the ocean

Seagrass appears to be present in the mid and upper parts of the estuary

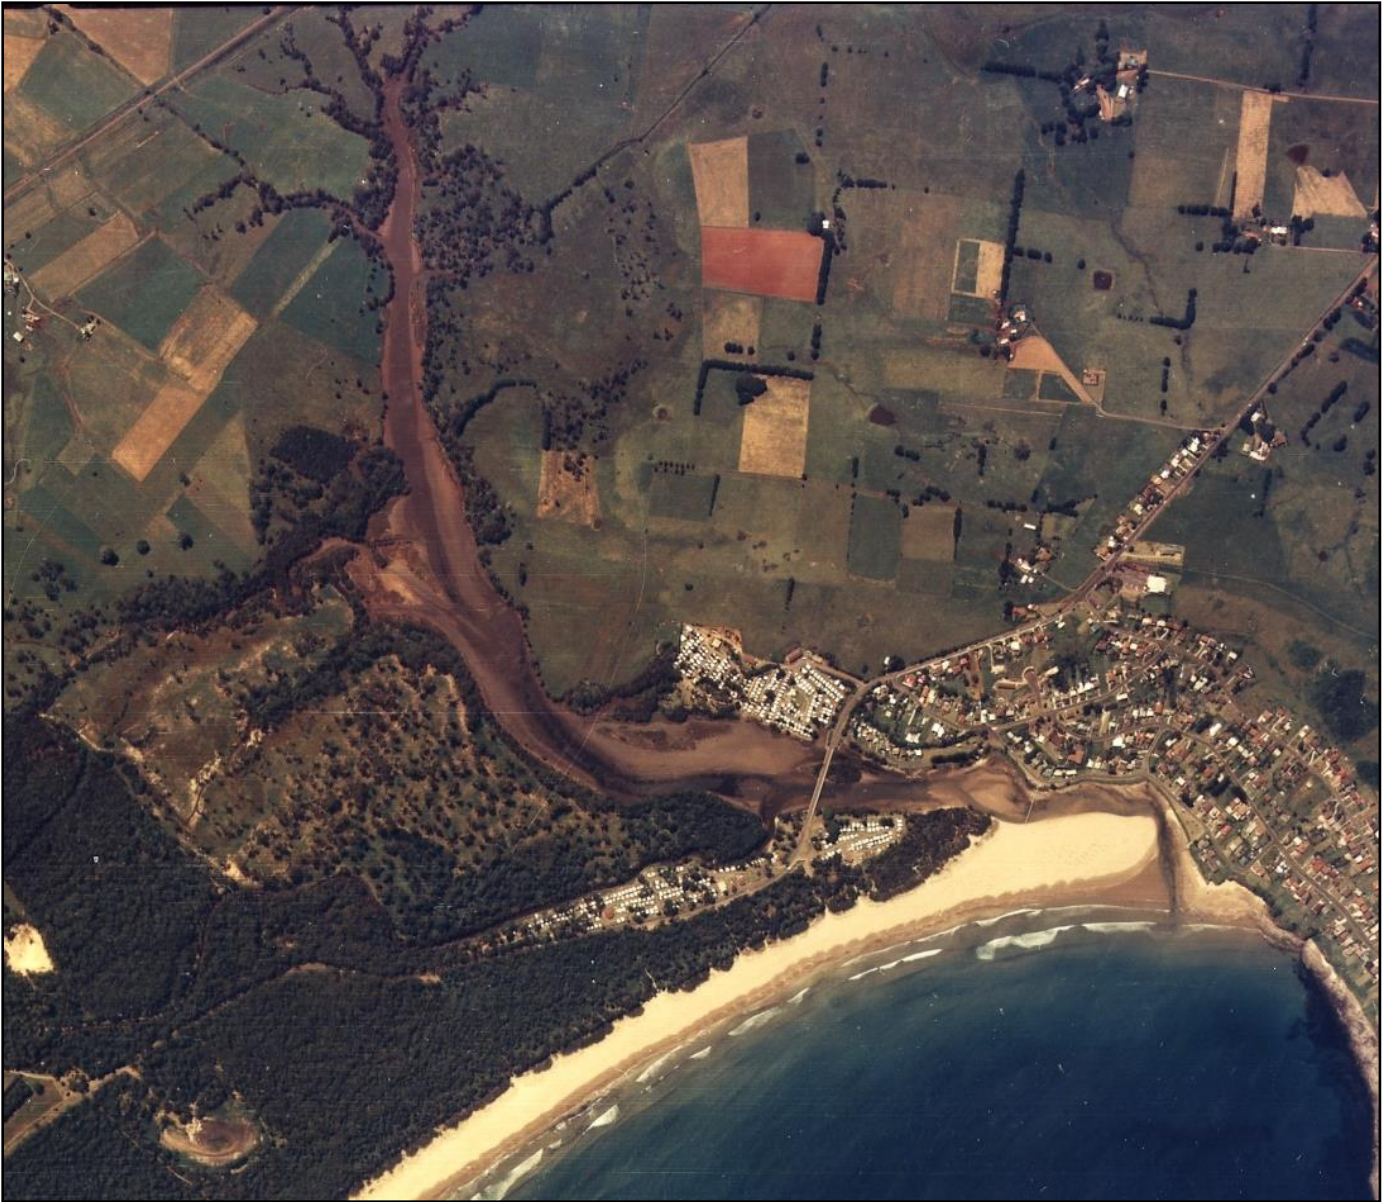
### **Crooked River Estuary 1993**

Estuary open to the ocean

Landfill site very visible

Further extension of northern caravan park

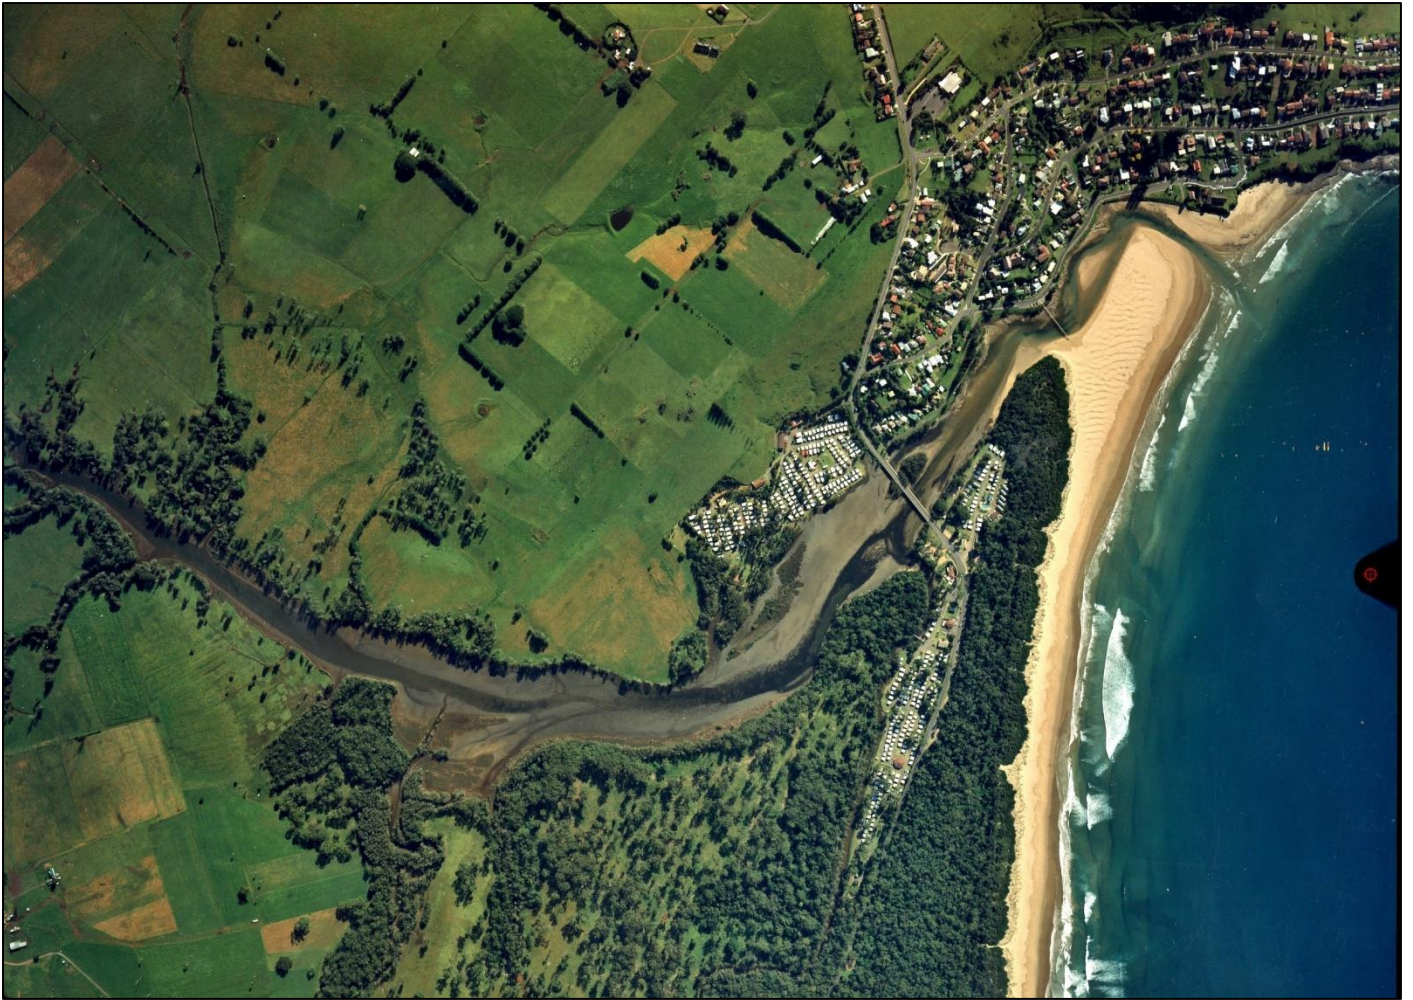
**Crooked River Estuary 1999**

Entrance open to the ocean

Sediment beds apparent in the mid estuary]

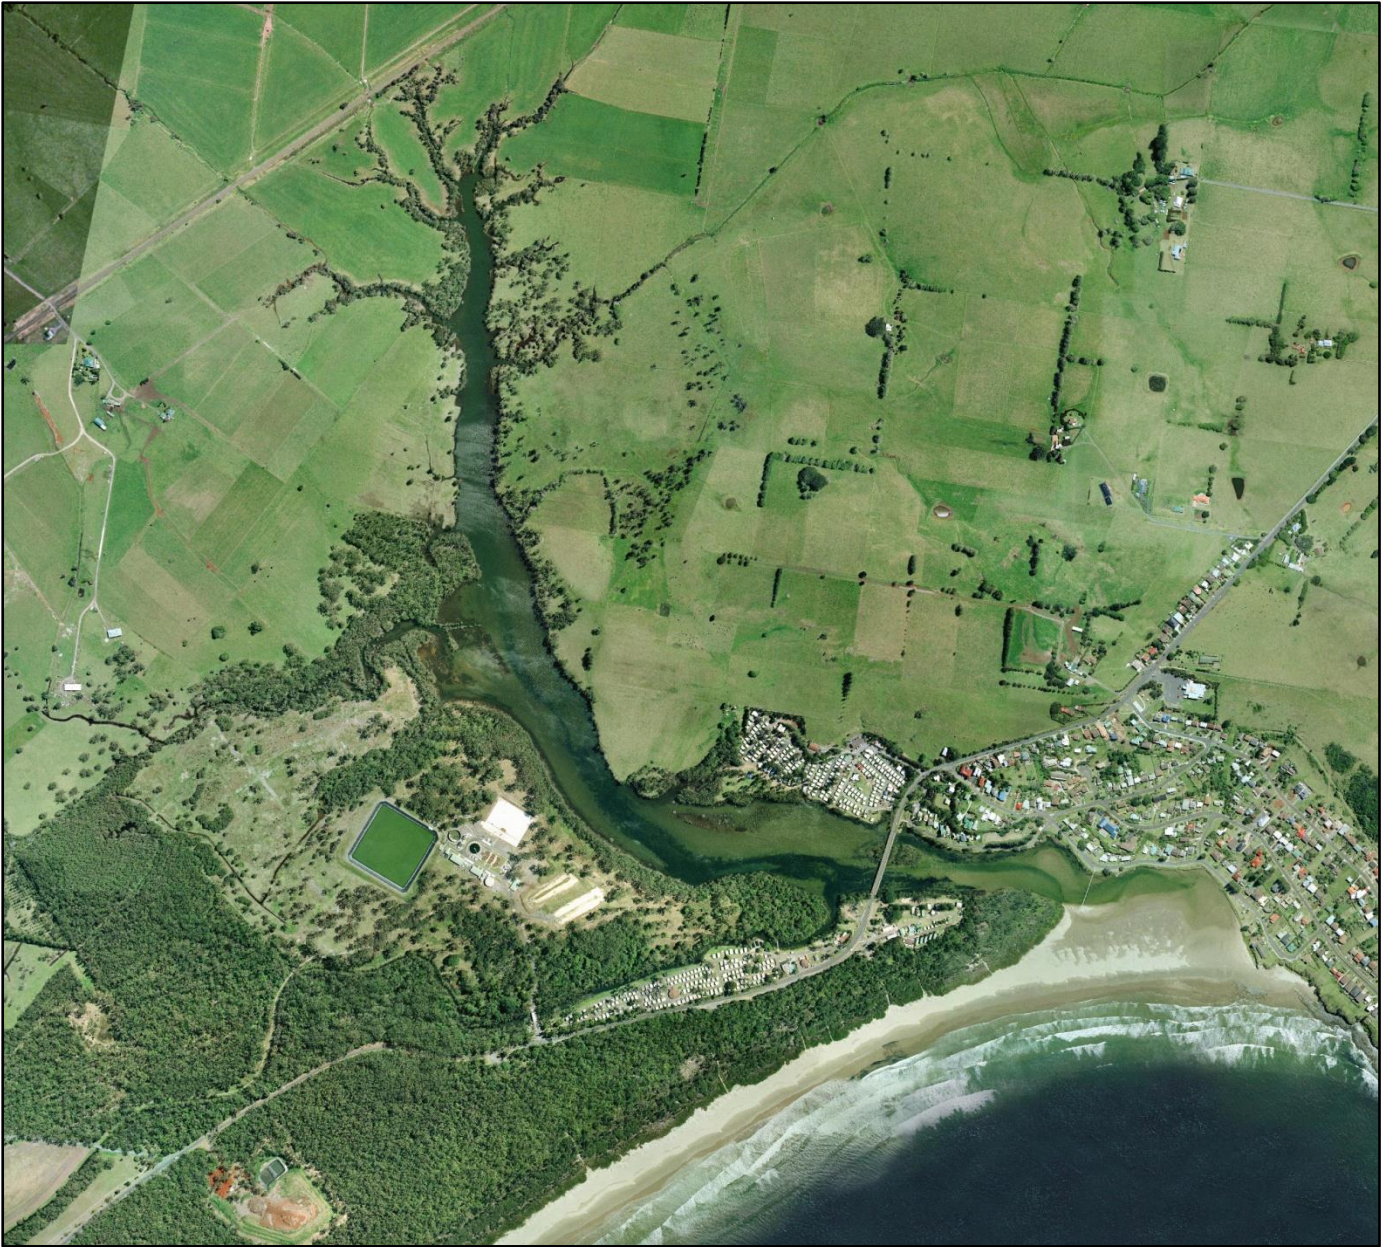
### **Crooked River Estuary 2003**

Estuary practically closed to the ocean

Landfill site under remediation

Seagrass appears to be present in the mid and lower estuary

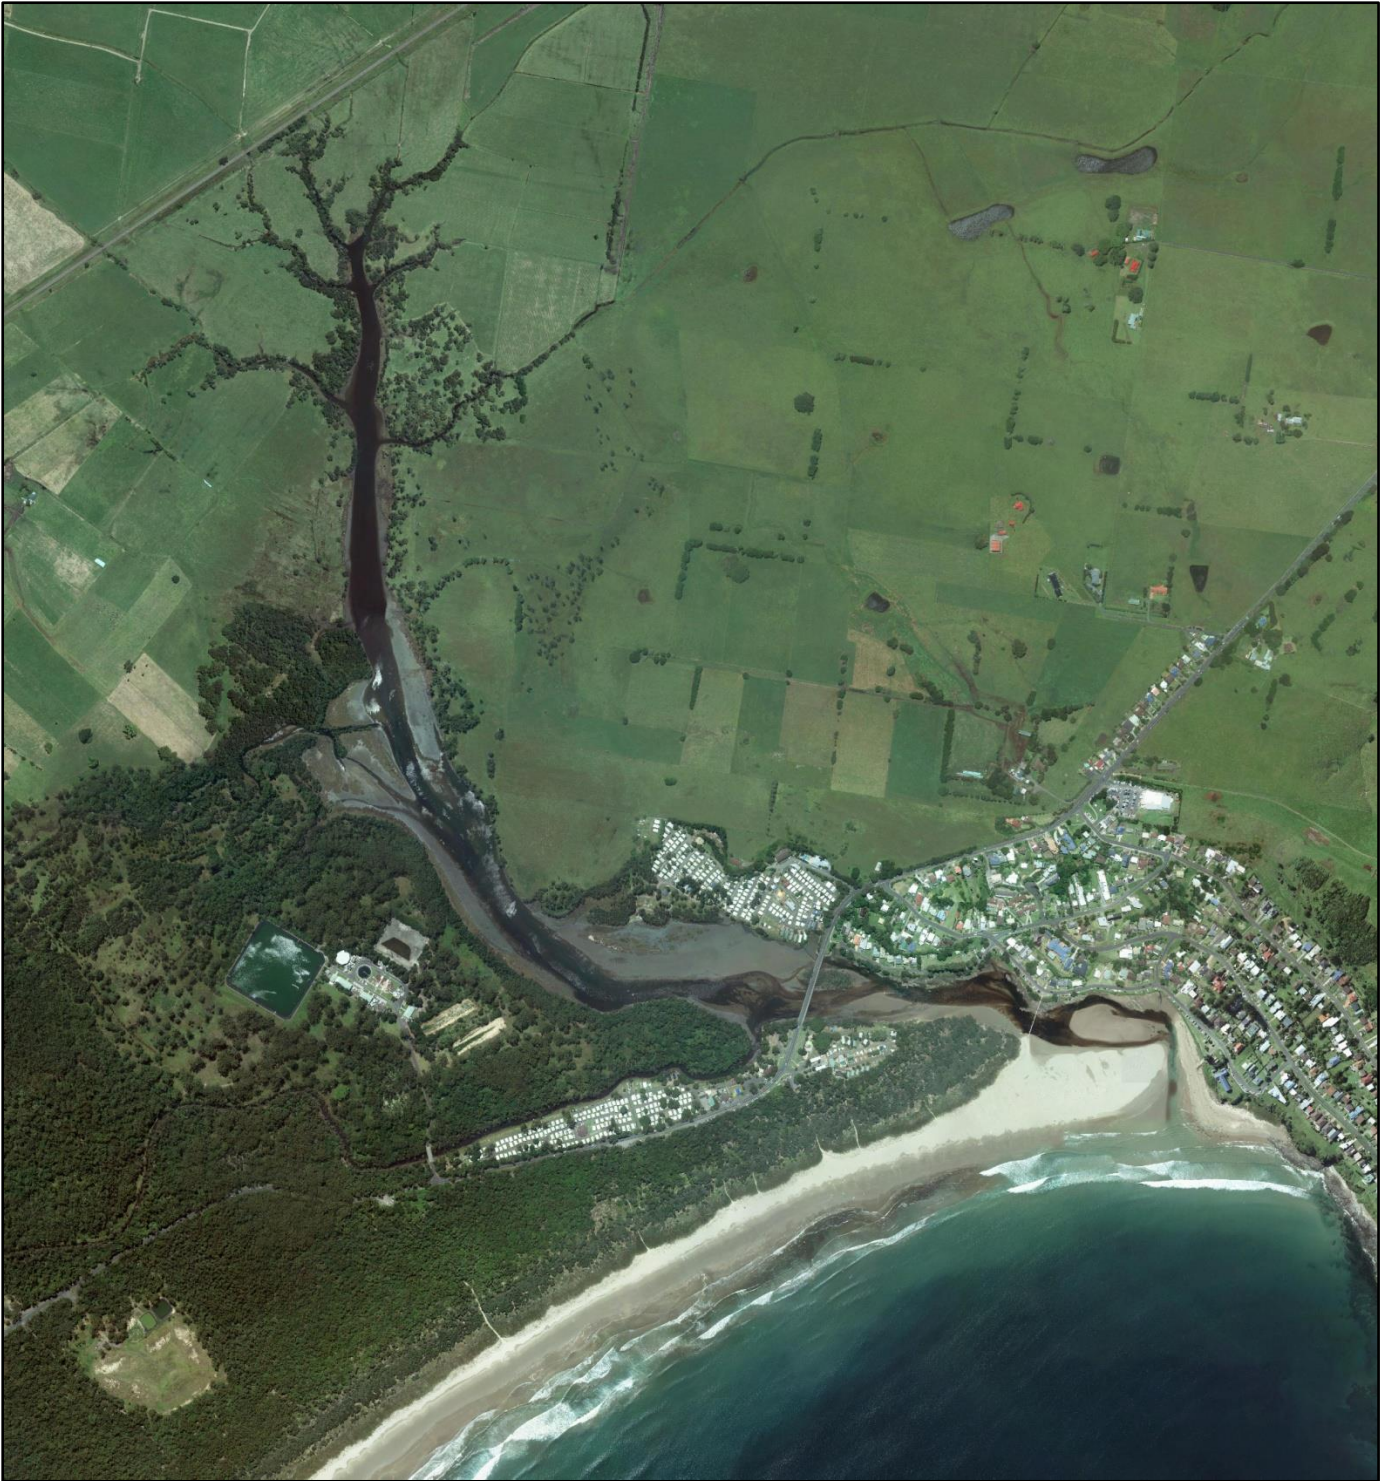
**Crooked River Estuary 2012**

Estuary open to the ocean

Seagrass beds visible in the mid and lower estuary

Noticeably turbid in the upper estuary

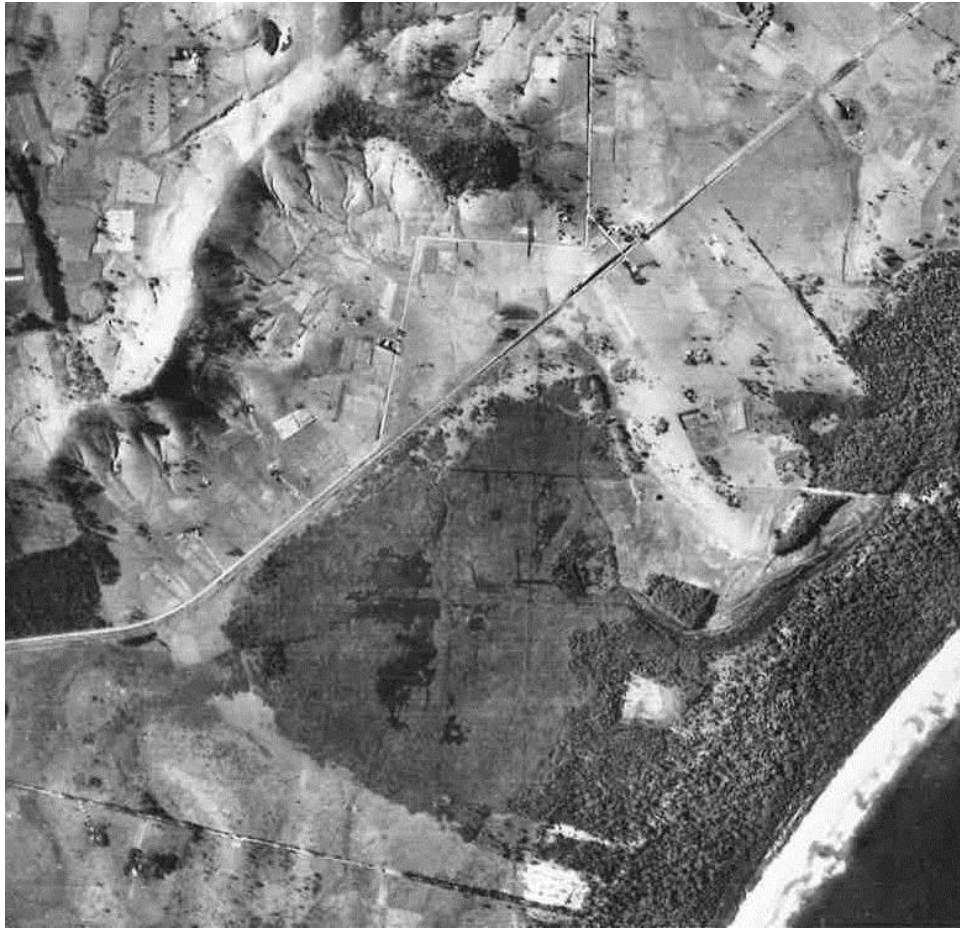
**Foys Swamp 1949**

Largely intact, northern part starting to get drained

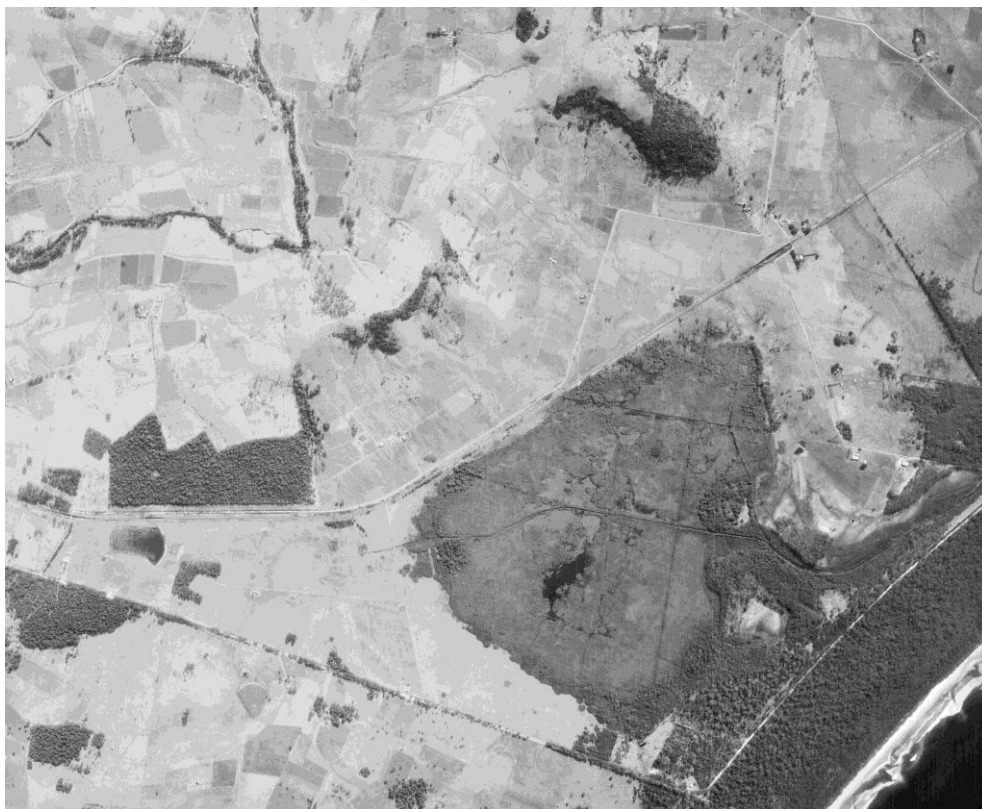
**Foys Swamp 1963**

Drains evident through middle of the swamp

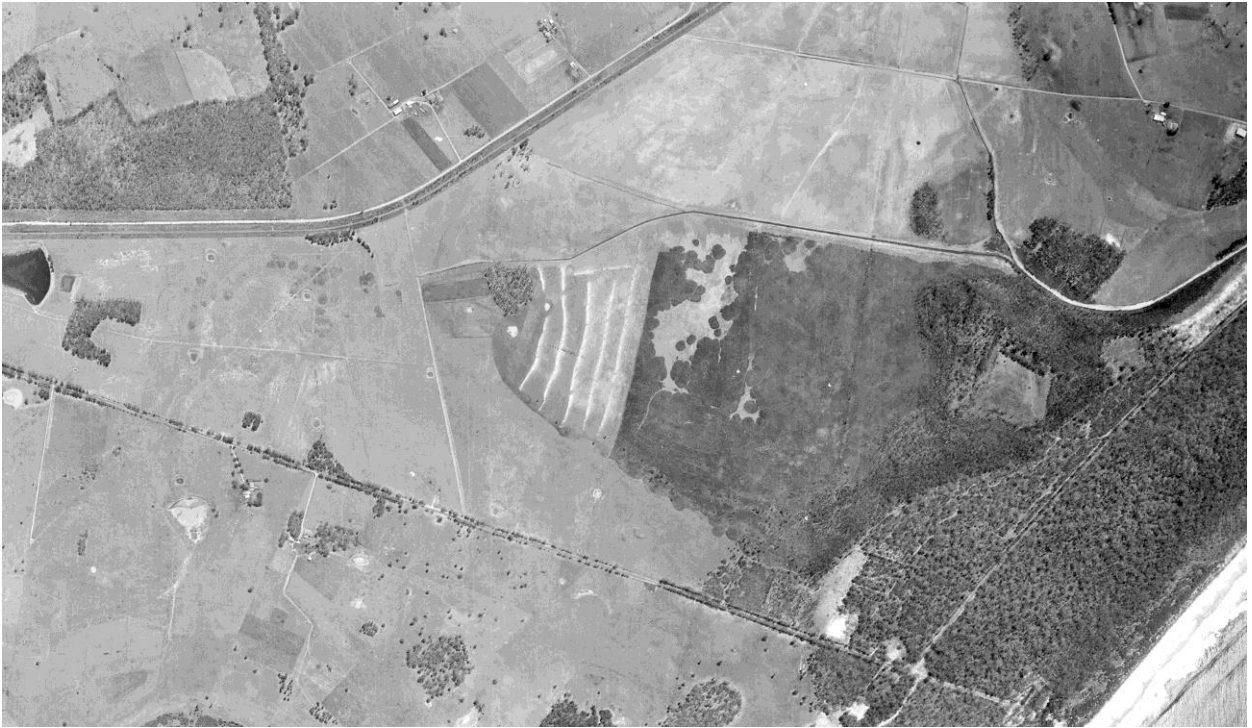
**Foys Swamp 1969**

Clearing of Swamp started

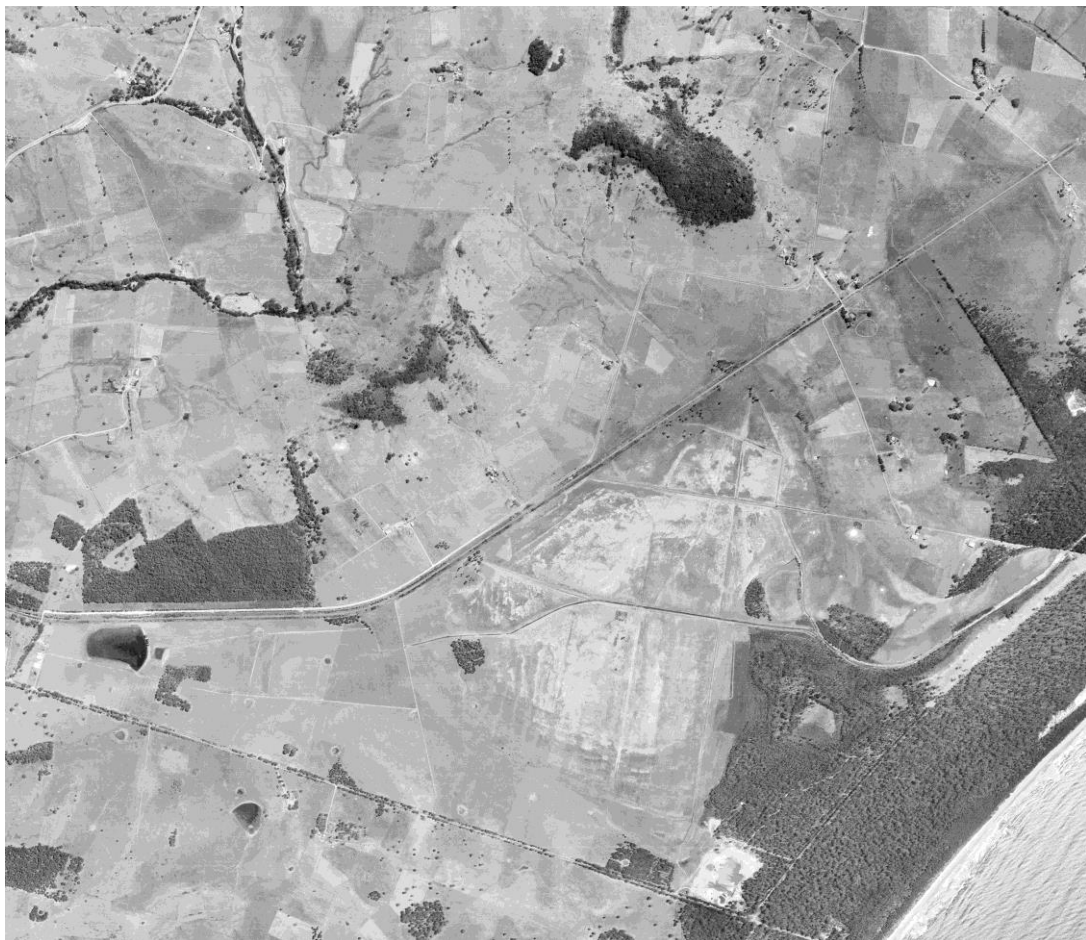
**Foys Swamp 1974**

Most of swamp clear, sand mining starting

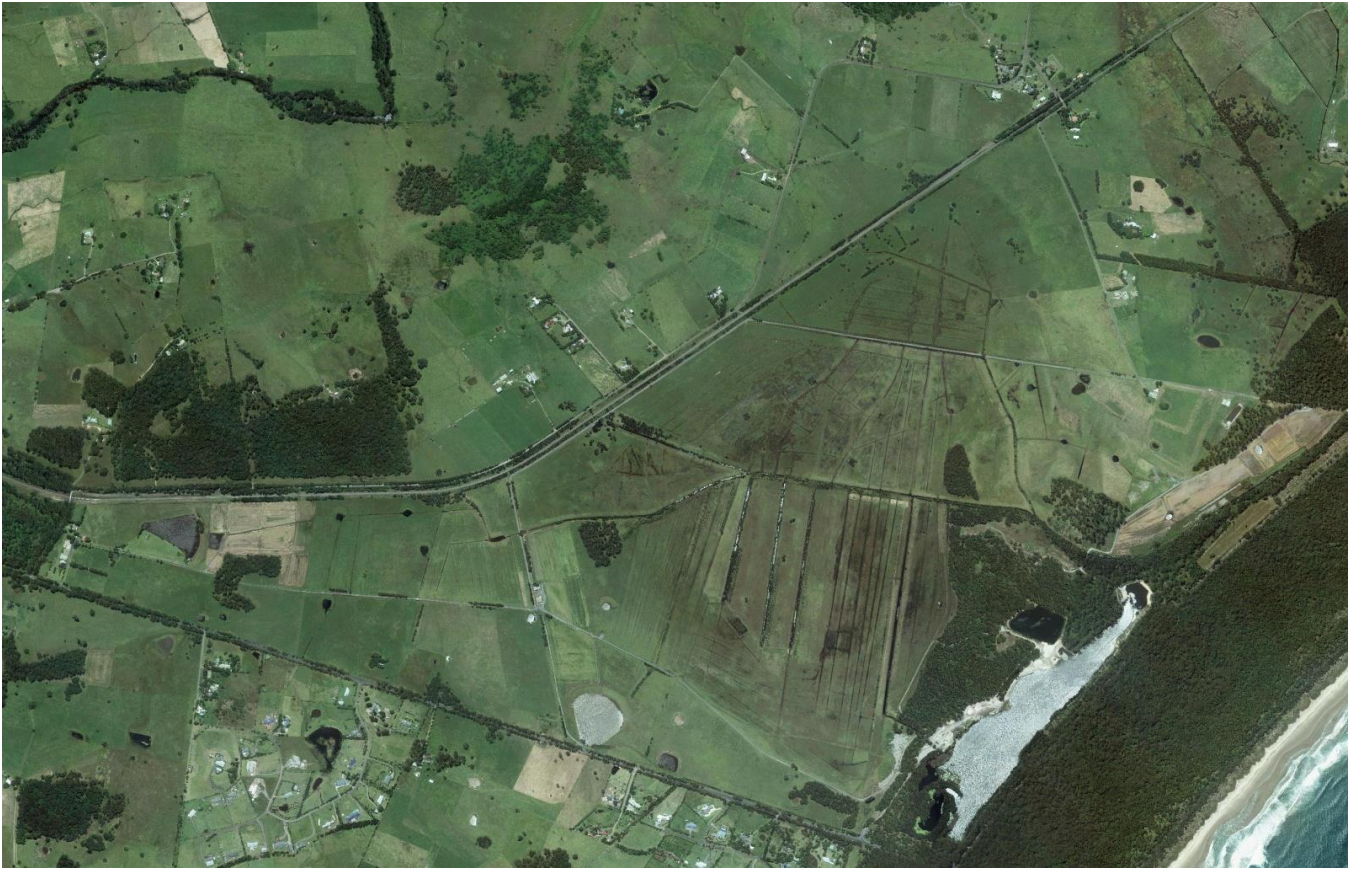
**Foys Swamp 2012**

Sand mine extended to almost current extent.
